Circular No: APSEZL/Marine/05/2025

Sub- Pilot Boarding / Disembarkation Arrangements at AVPPL

DGS Circular No. 19 of 2025

Guidelines for the Safe Transfer of Seafarers, Pilots etc. using Pilot ladders, Gangways or Combination ladder etc. to / from a service boat or launch or a barge or crafts.

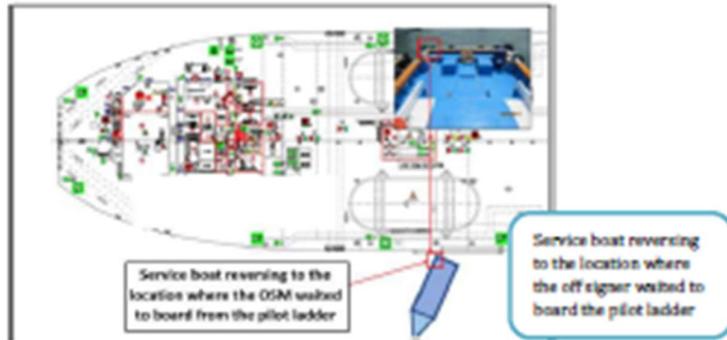
Figure 2: Indicating the service boat angle of approach. Source: TSIB report

In the first case, the prevailing sea conditions were not properly assessed. The rough seas led to a misalignment between the pilot ladder and the service boat, creating a highly unsafe environment for personnel transfer. Despite the visible risk posed by strong swells, the operation continued without implementing any safety interventions. The disembarking seafarer, who was not wearing appropriate PPE, lost his grip and fell into the water.

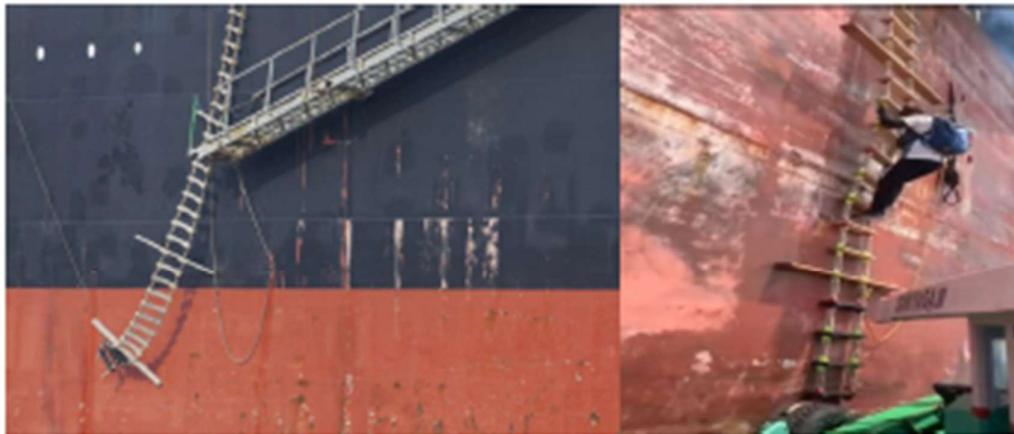
Figure 3: Illustration of a seafarer disembarking from a vessel through a pilot ladder with inadequate PPE

6. **Personal Protective Equipment (PPE):** Transfer personnel must wear life jackets and should not carry backpacks or baggage during the transfer. Transfer the baggage or other items using a heaving line. Both the victims were not wearing life jackets at the time of incident. Life jacket could have kept the victim afloat even after falling in water which could have helped in rescue.
