Sub: Half yearly Compliance report of Environmental and CRZ clearance for Vizhinjam International Multipurpose Deepwater Seaport for the period of **April 2019 to September 2019** – Reg.

Adani Vizhinjam Port Private Ltd	From : April 2019 To : September 2019
Vizhinjam International Deepwater Multipurpose Seaport Status of Conditions Stipulated in Environmental and CRZ Clearance

Half Yearly Compliance Report on Conditions Stipulated in Environmental & CRZ Clearance

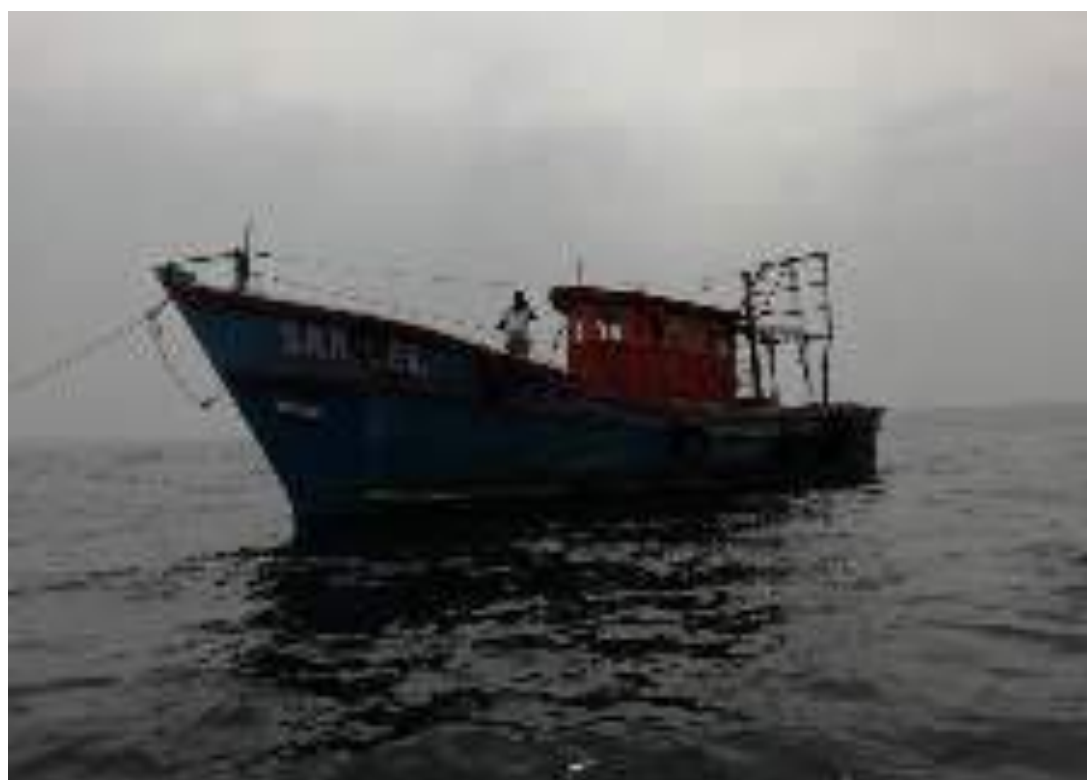
Figure 4– Survey / Watch Keeping Vessel MFB Samuel

The following vessels were utilised for the survey operations.

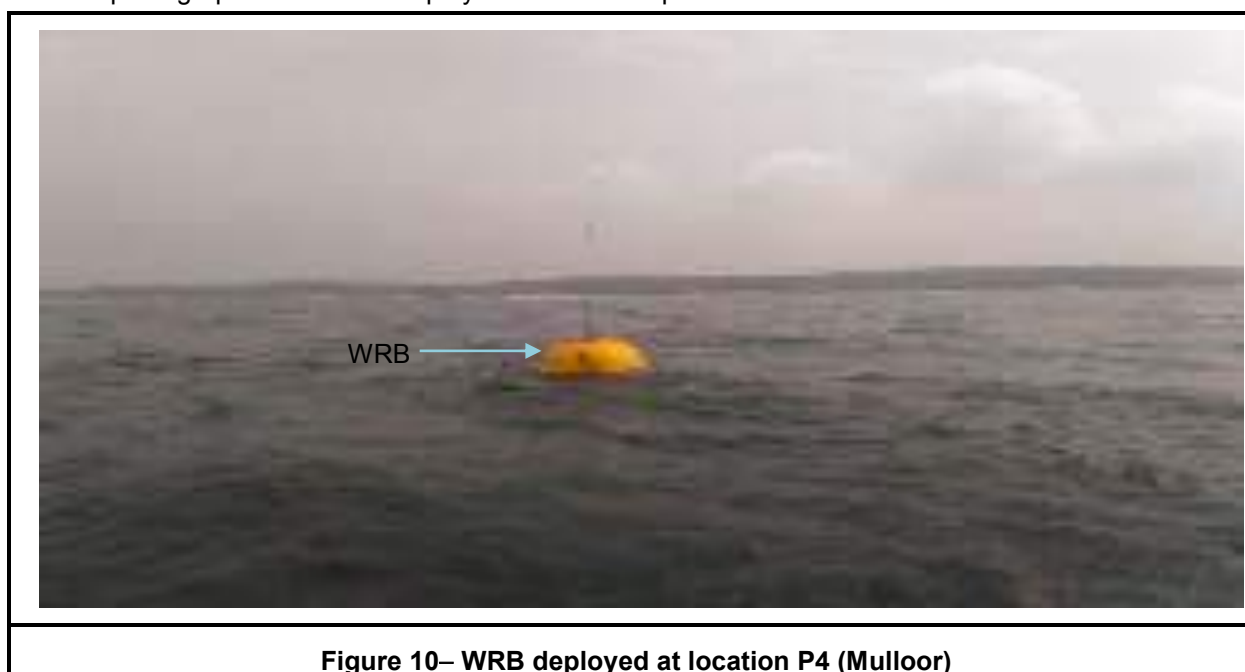
A photograph of the WRB deployed at the site is provided below:

A highly elastic rubber cord is essential for high quality wave measurements. It allows the buoy to follow the wave motion, thus guaranteeing that the measured motion of the buoy is indeed the same

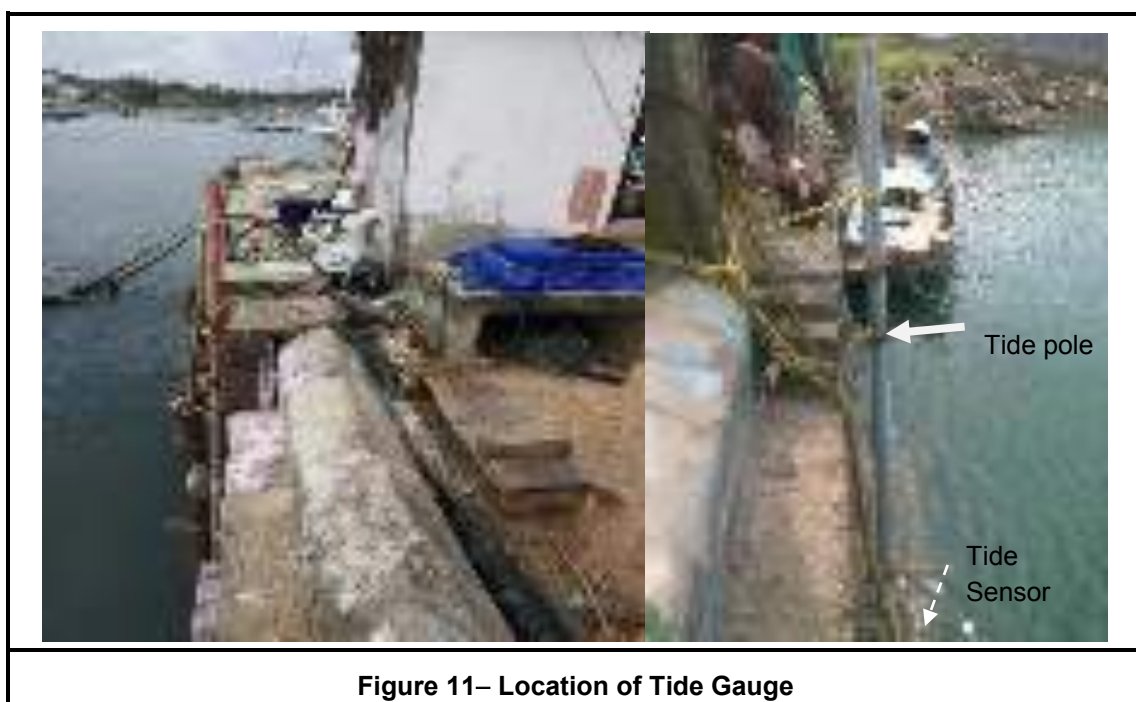
Figure 11– Location of Tide Gauge

A Valeport 740 Tide master automatic tide gauge was installed near the Coast Guard jetty, inside the fishing harbour for measuring the tides. The location is close to the existing tide gauges installed by NIOT. The sensor was installed on a 5m long pipe to ensure that the sensor is always in water, irrespective of the phases of tide. This was levelled to the local bench mark, situated on top of the jetty. The tide station was programmed to measure the tide at 6-minute intervals throughout the duration of the project.

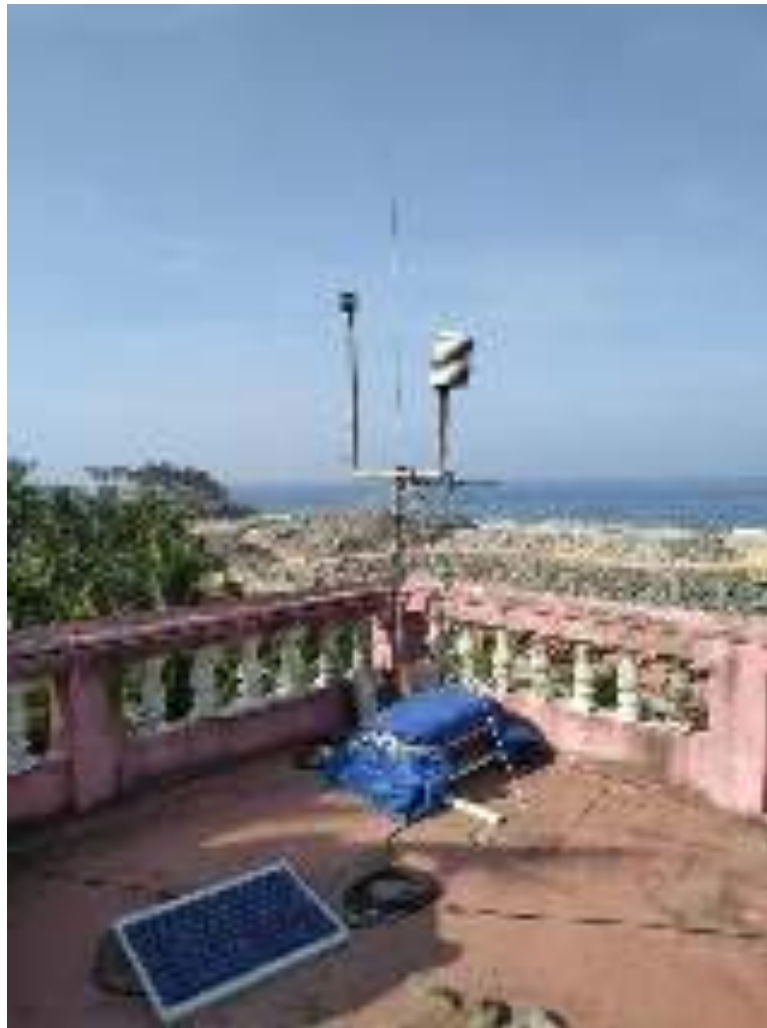
Figure 12 – Automatic Weather Station on top of Ayur Bay Resort, Nellikunnu (Mulloor)

The data is logged in a data logger installed at the receiving station at intervals of 10 minutes. The data is also transmitted from the data logger through a UHF link to a remote PC for QC and processing.

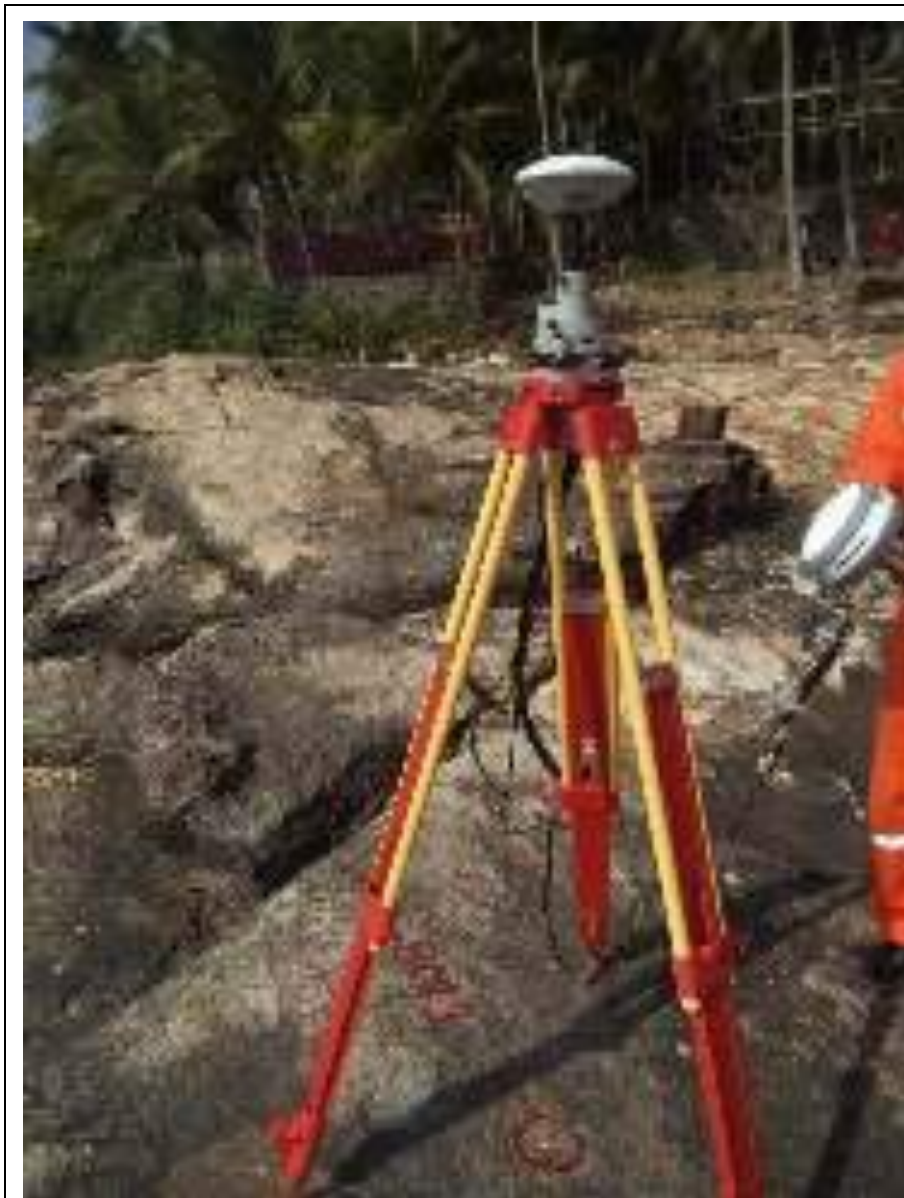
Figure 13 – RTK System fixed at BM-1

- Hemisphere GPS R320 GNSS base station
- Hemisphere GPS R320 rover

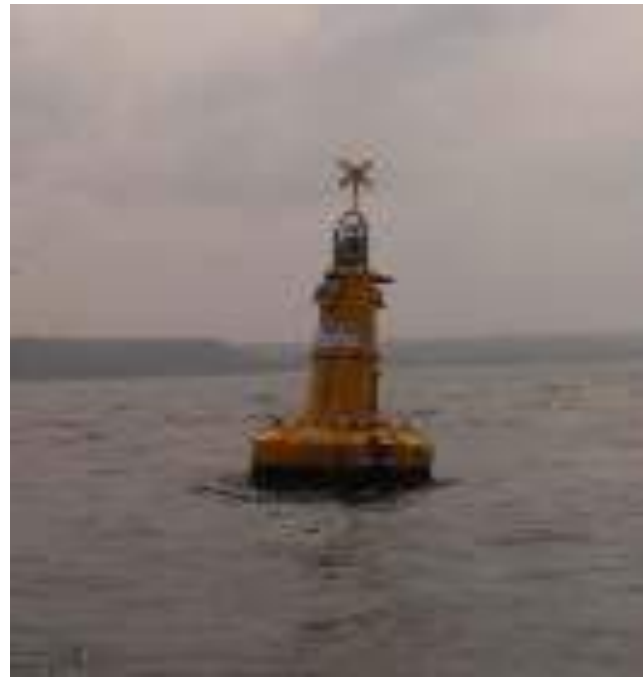
Figure 15 – Turbidity Buoy

The data from the buoy is received at the receiving centre at Ayur Bay resort at intervals of 10 minutes.

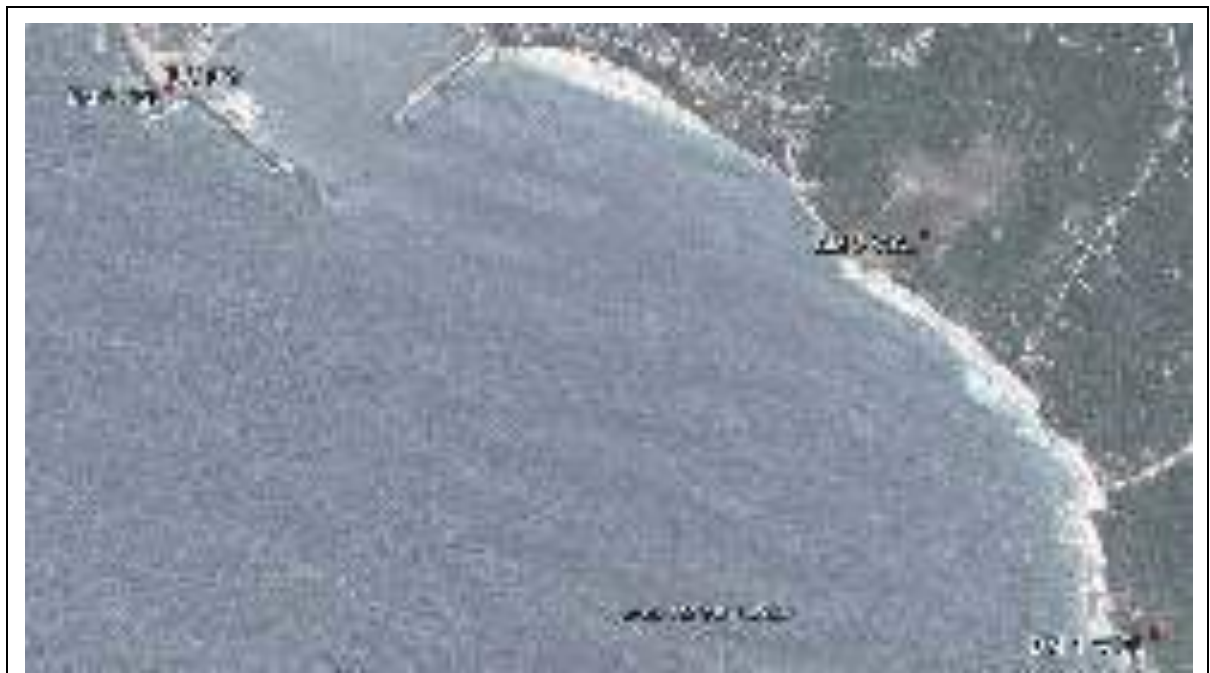
Figure 16 – Benchmark locations

The co-ordinates of BM-1 and BM-2 were provided by VISL (Detailed Project Report on Rail Connectivity to Vizhinjam International Seaport: Kerala, 2011) prior to the start of the survey. BM-1 lies next to the Sri Nagar Bhagavathy Temple, Mulloor. BM-2 consists of a chiselled square on the rock adjacent to the compound wall of the Kollamkodu Sahib Dargah at Vizhinjam. BM-3 was set up on the roof of the VISL Project Office. The Survey of India Benchmark (SOI BM) which lies on a rock adjoining the basement on the western side of Vizhinjam mosque was also provided. This point is 6.945m above chart datum.

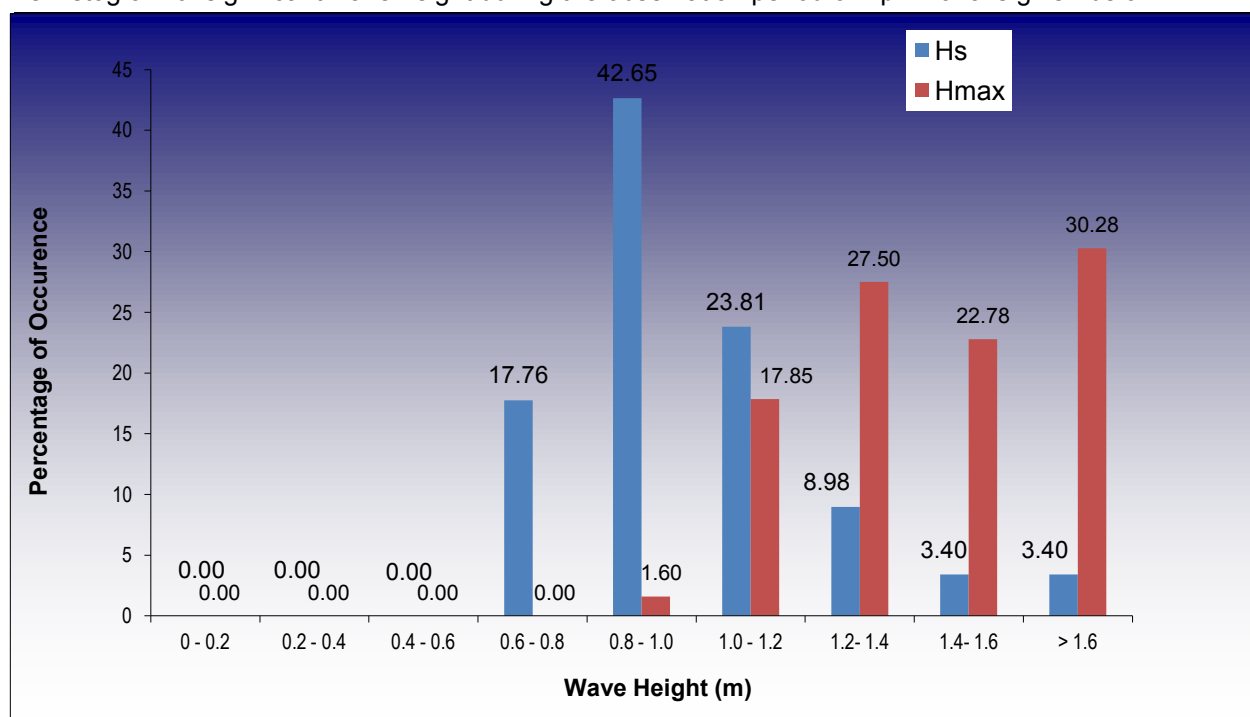
Figure 19 – Histogram of wave height (1st to 30th April 2019)

The histogram of significant wave height during the observation period of April 2019 is given below:

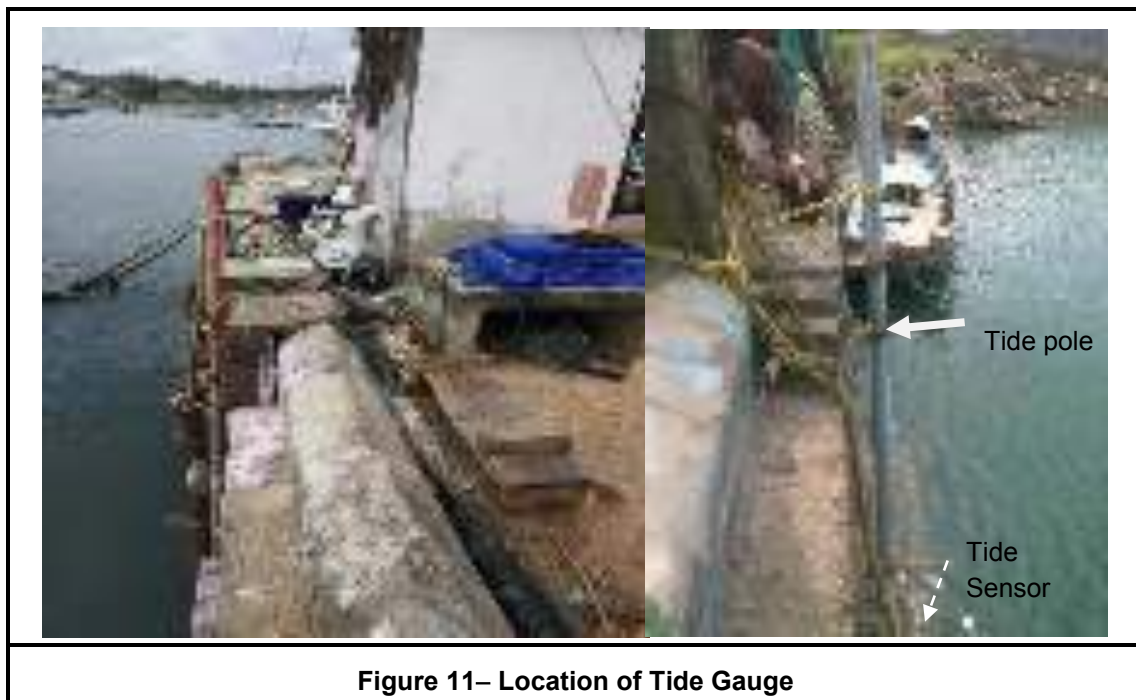
Figure 11– Location of Tide Gauge

A Valeport 740 Tide master automatic tide gauge was installed near the Coast Guard jetty, inside the fishing harbour for measuring the tides. The location is close to the existing tide gauges installed by NIOT. The sensor was installed on a 5m long pipe to ensure that the sensor is always in water, irrespective of the phases of tide. This was levelled to the local bench mark, situated on top of the jetty. The tide station was programmed to measure the tide at 6-minute intervals throughout the duration of the project.

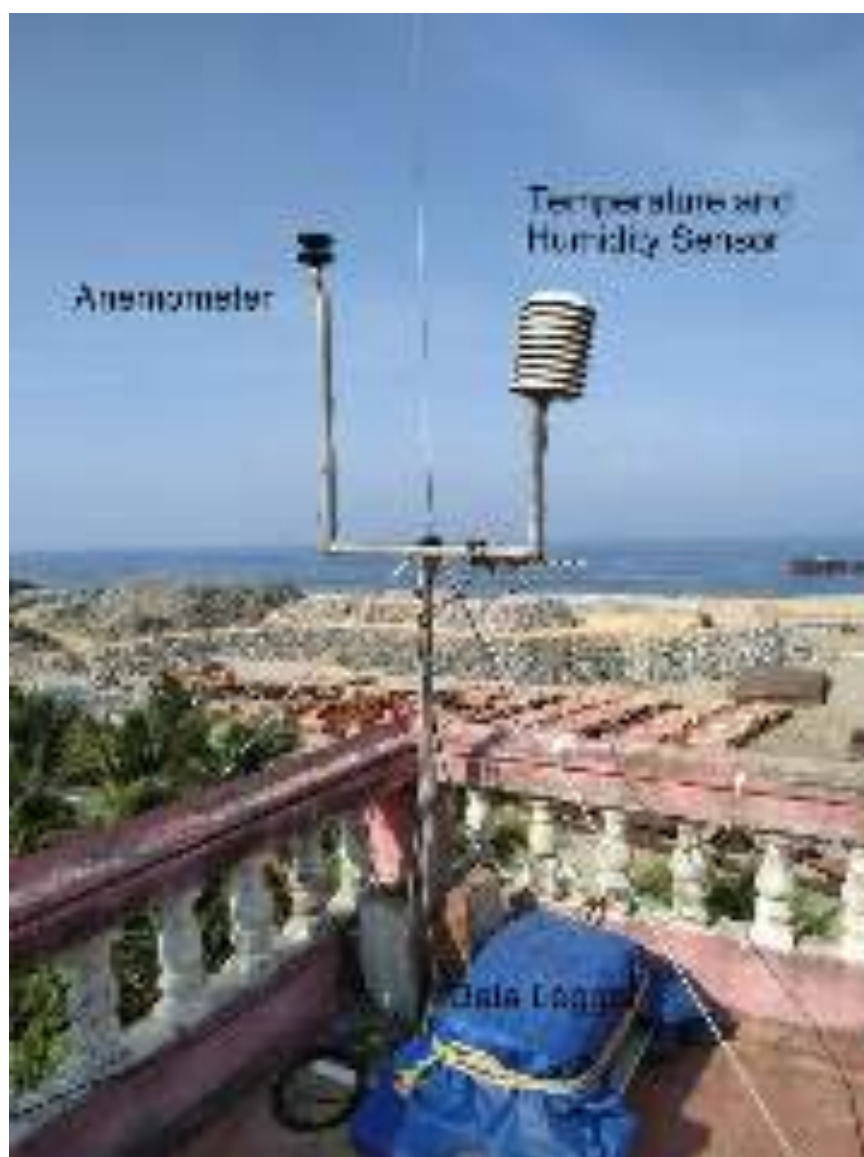
Figure 12 – Automatic Weather Station on top of Ayur Bay Resort, Nellikunnu (Mulloor)

The data is logged in a data logger installed at the receiving station at intervals of 10 minutes. The data is also transmitted from the data logger through a UHF link to a remote PC for QC and processing.

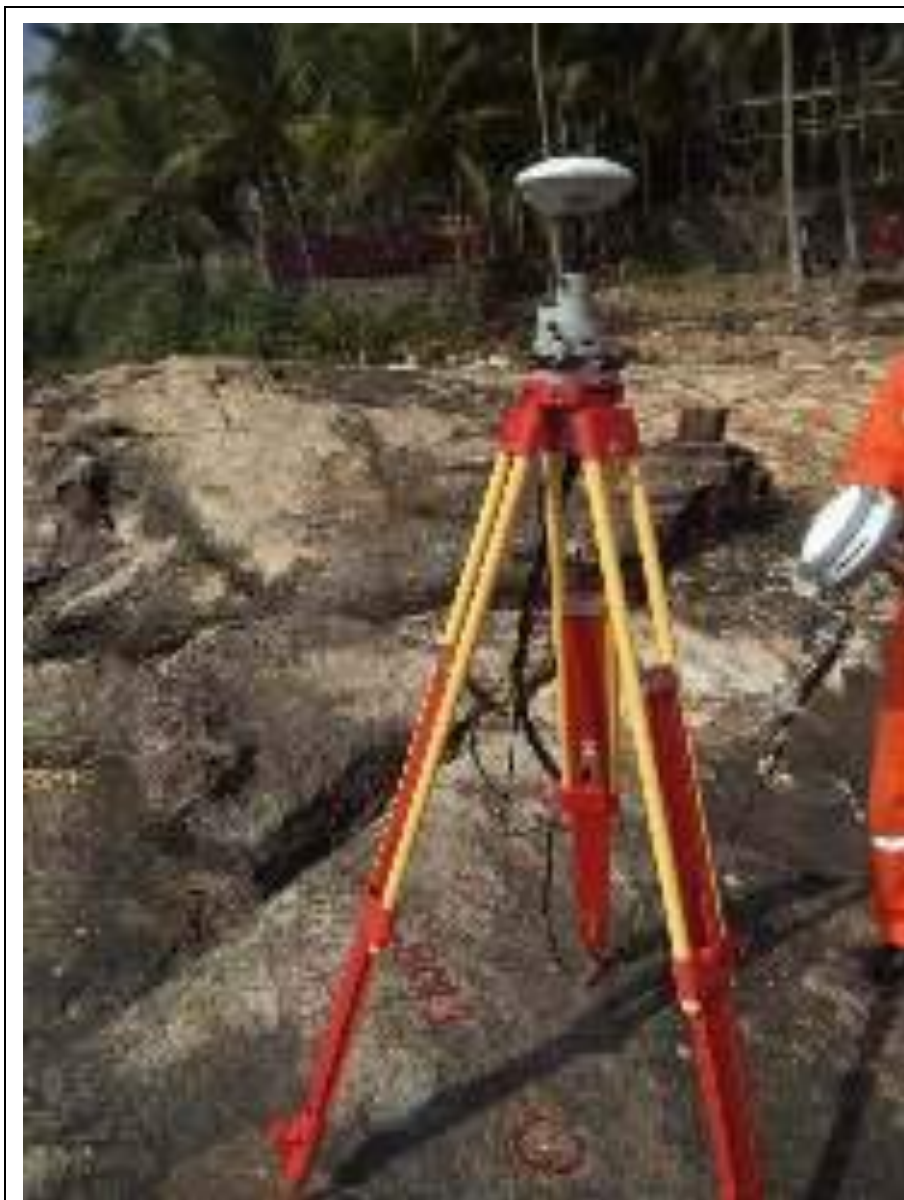
Figure 13 – RTK System fixed at BM-1

- Hemisphere GPS R320 GNSS base station
- Hemisphere GPS R320 rover

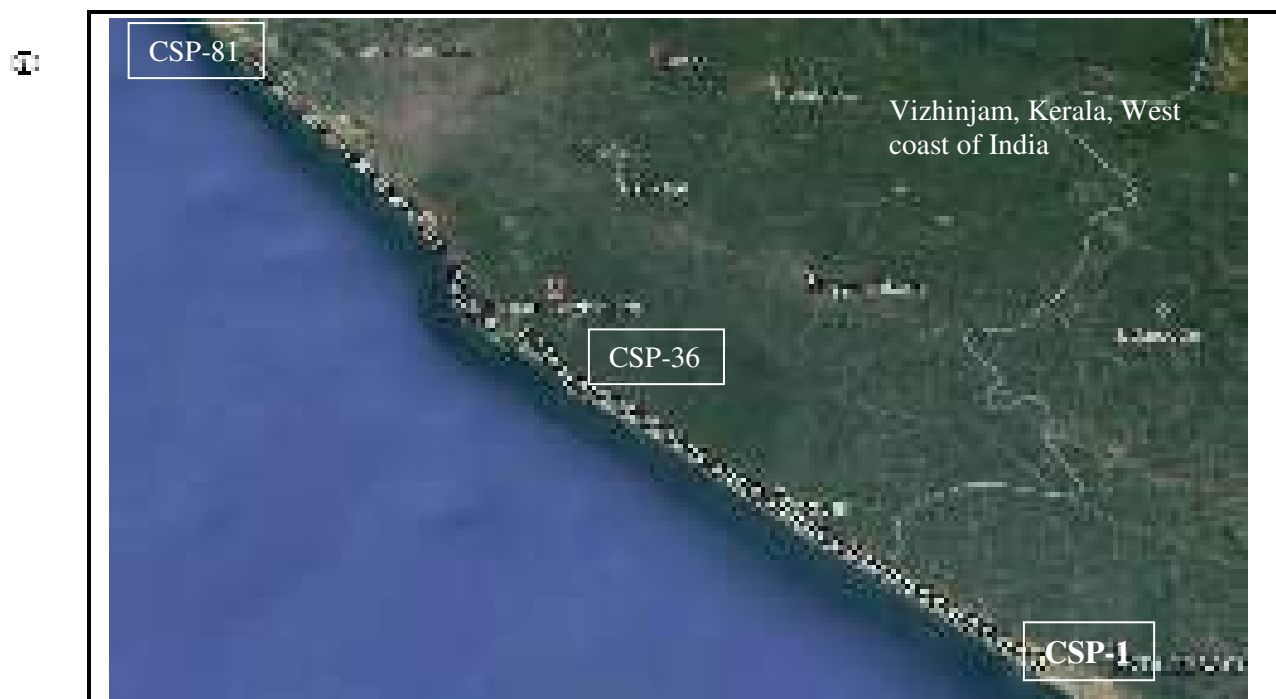
Figure 2-2: CSP, LEO and Photographic Documentation Locations

The cross-shore profiling lines, which coincides with the LEO, beach sampling and photographic documentation, are indicated in the image below. The cross-shore profiles are named as CSP-01 to CSP-81. CSP-01 corresponds to the southernmost profile which lies to the south of the existing Vizhinjam Harbour.

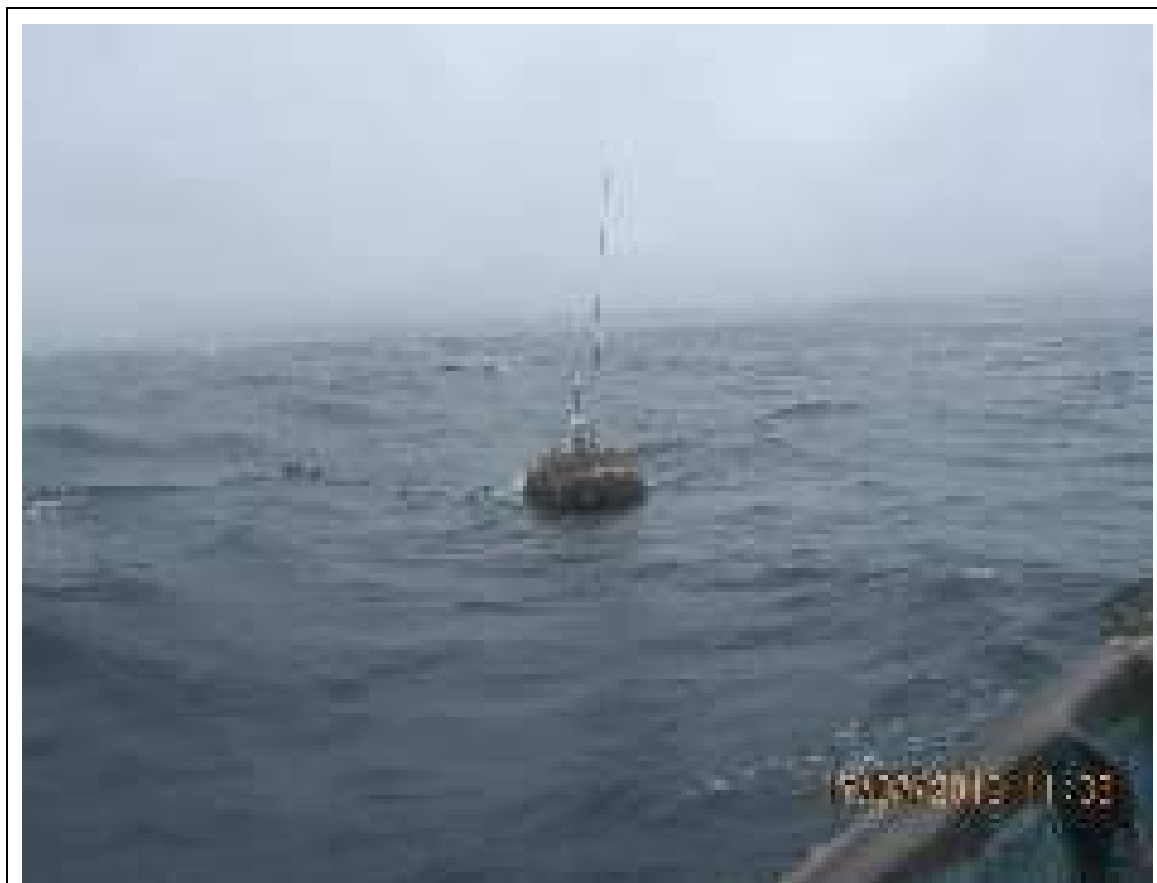
The image of WRB deployed at the location is provided below:

Figure 5-2: WRB deployed at site

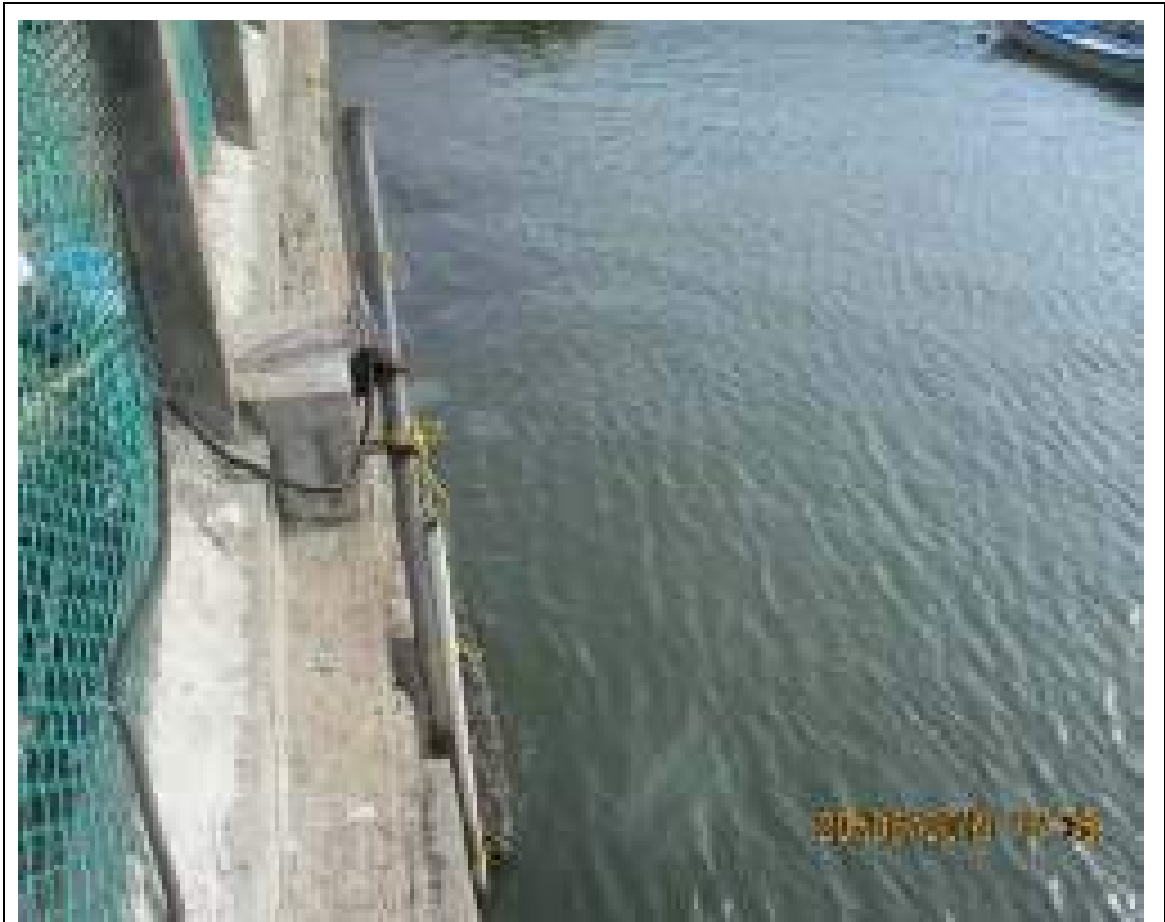
Figure 5-3: Tide Gauge

An EMCON automatic tide gauge was installed near the Coast Guard jetty, inside the fishing harbour for measuring the tides. The tide gauge is a capacitance-based instrument, measuring the water level due to change in capacitance on the surface of sensor. The sensor was installed on a 2.5m long pipe to ensure that the zero of sensor is always in water, irrespective of the phases of tide. This was levelled to the local benchmark, situated on top of the jetty. The tide station was programmed to measure the tide at 5-minute intervals throughout the duration of the project.

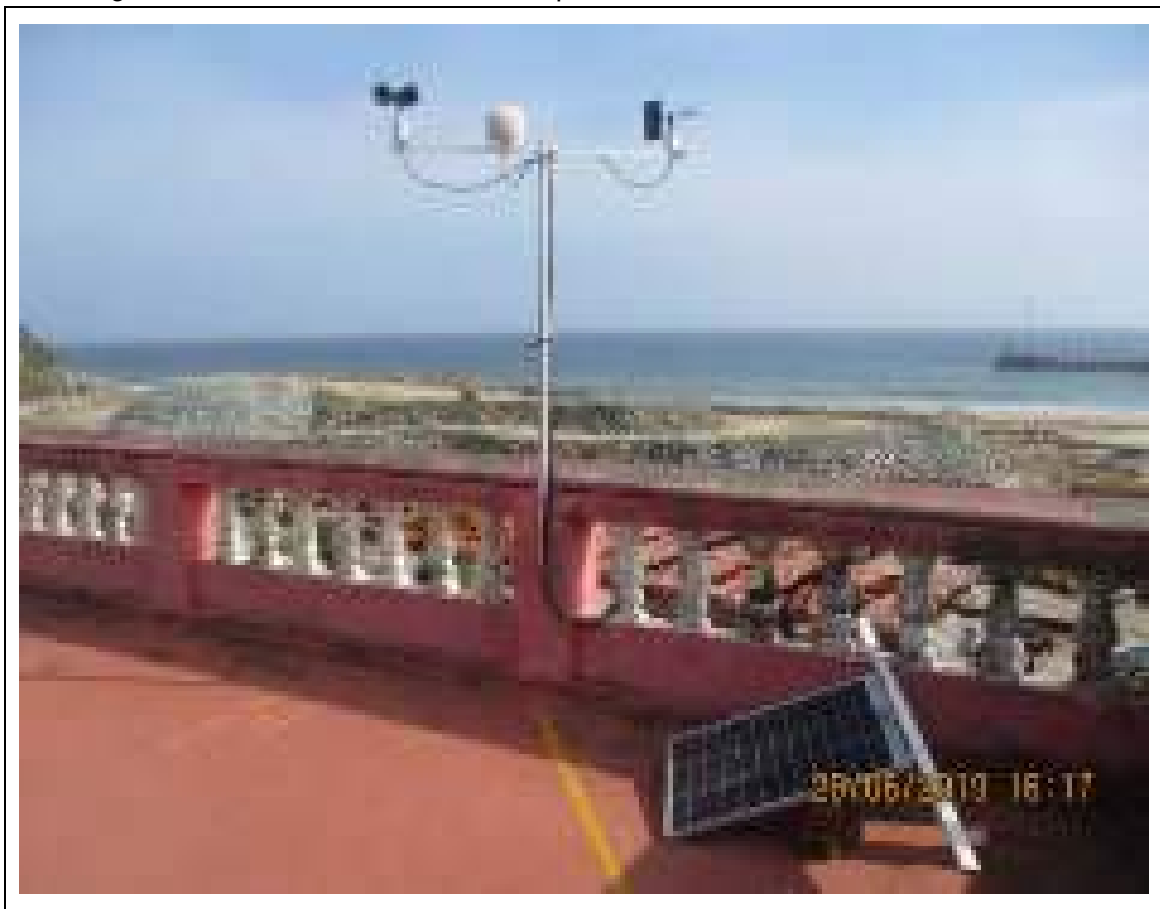
Figure 5-4: AWS on toop of Ayur Bay Resort, Nellikunnu (Mulloor)

The data is logged in a data logger installed at the receiving station at intervals of 10 minutes. The data is also transmitted from the data logger to a cloud bases server for further processing and QC checks.

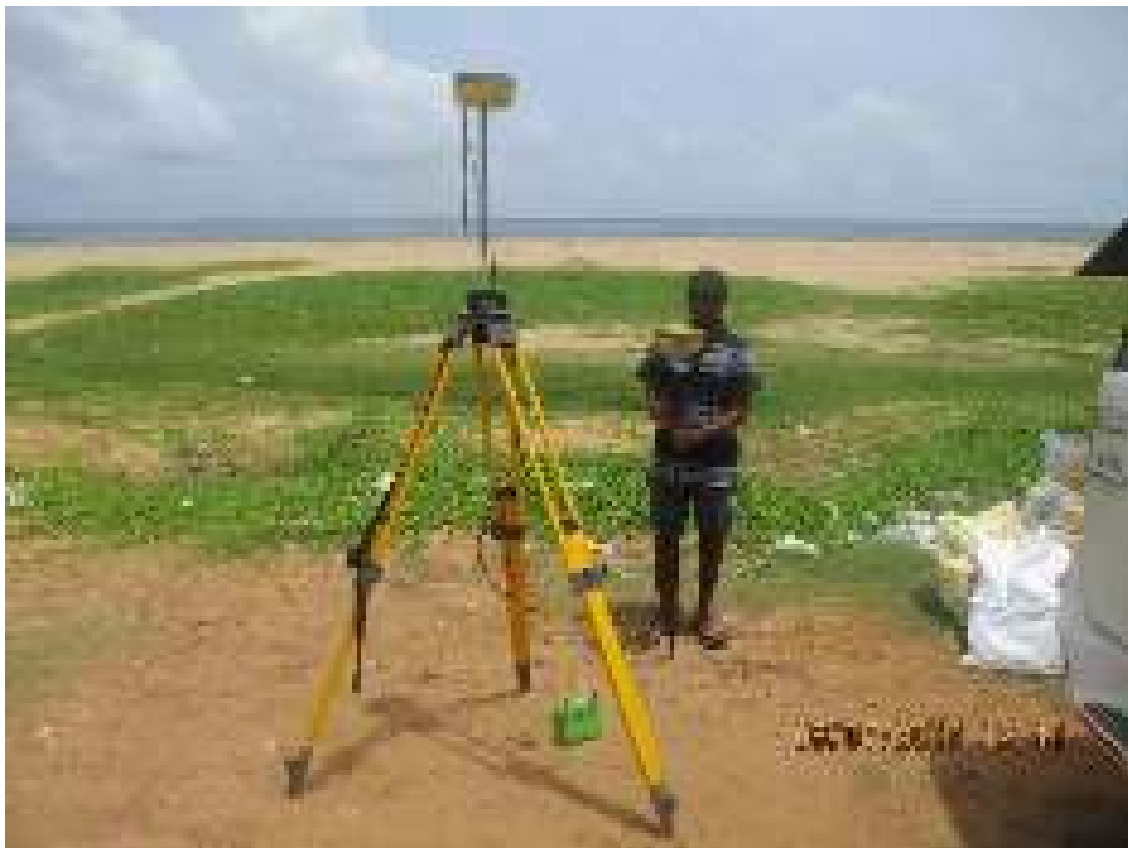
Figure 5-5: RTK System with base station and rover

An RTK system was mobilized at site to carry out cross-shore profiling on the landward side. The system used was a Geomax Zenith 10/20 RTK system with base station and rover. A photograph of the system is provided below:

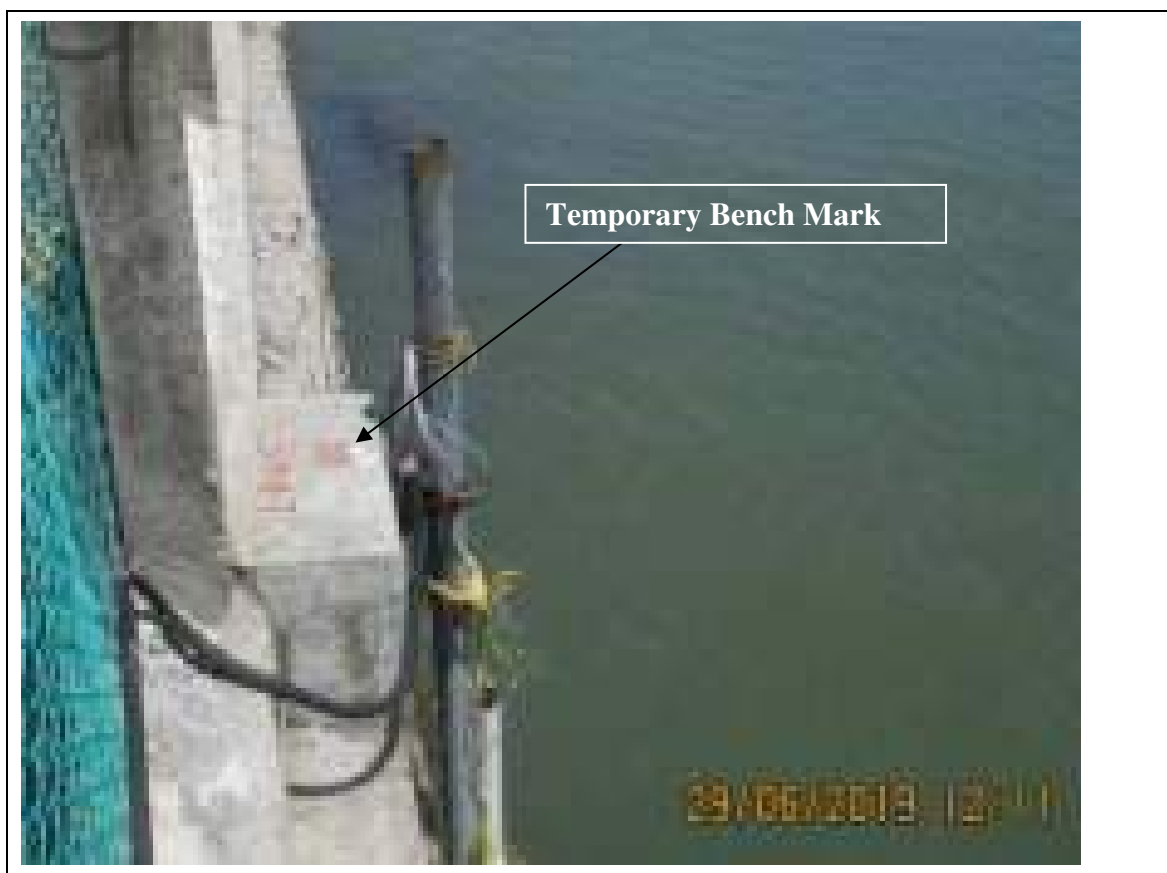
- ① The tides were observed near the Coast Guard jetty. The tide is referenced to the chart datum, the value of which was provided by VISL. The temporary benchmark is marked on the wharf and is 3.447 above chart datum. An image of the TBM is provided below:

Figure 6-1: Location of TBM

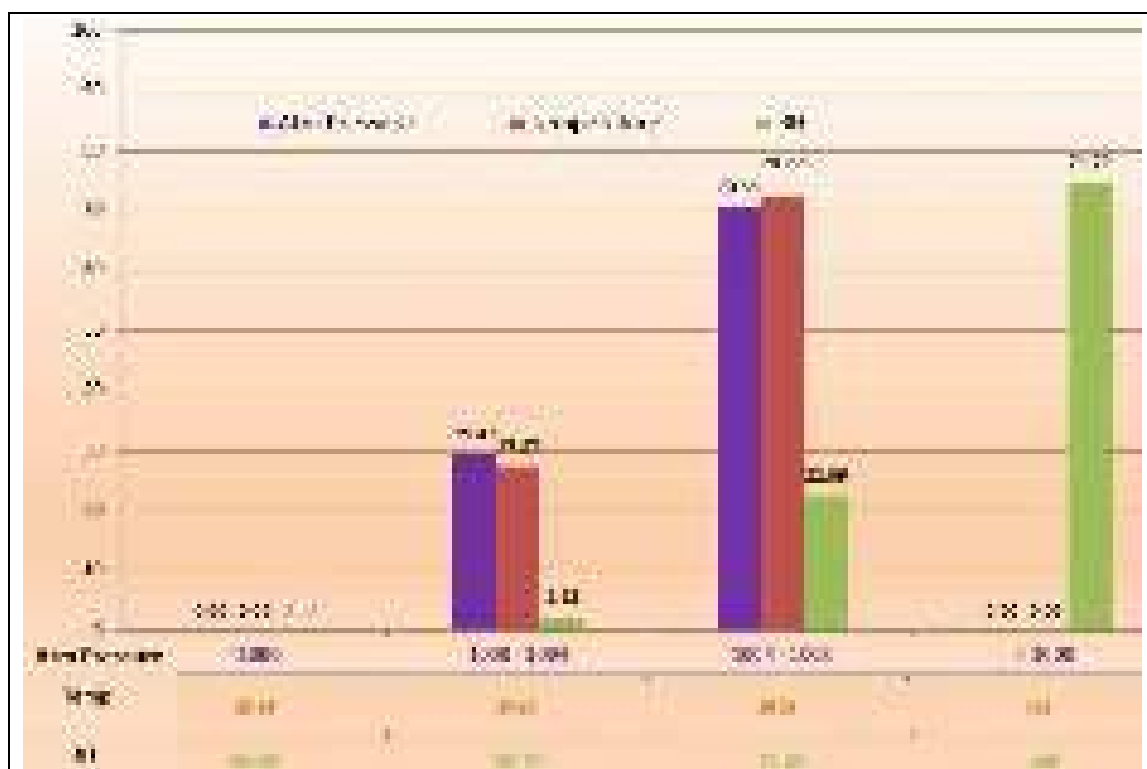
Figure 6-10: Histogram of Met parameters from 4th to 30th June 2019

The data represented above reveals that about 99% of the atmospheric pressure recorded for the month was between 1000mb and 1004 mb. The temperature was between 24 to 32°C during the month. The relative humidity was greater than 80% during 74.7% of the observations indicating monsoonal conditions.

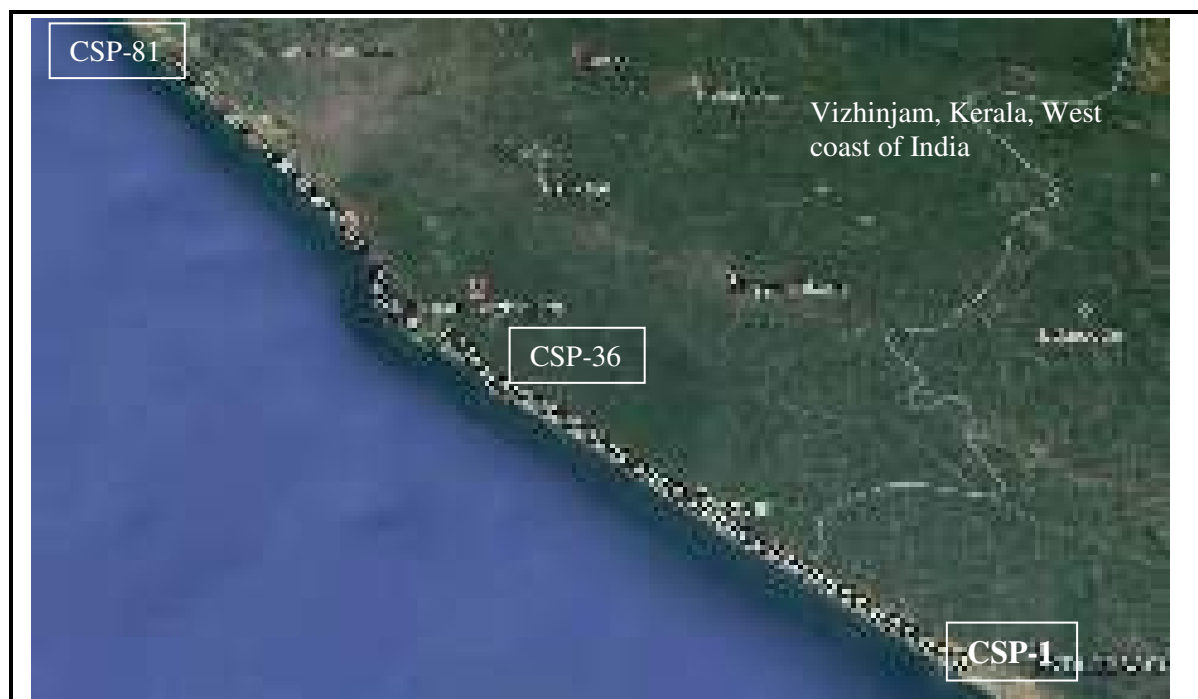
Figure 2-2: CSP, LEO, Beach Sampling and Photographic Documentation Locations

- ① The cross-shore profiling (CSP) lines, which coincides with the LEO, beach sampling and photographic documentation, are indicated in the image below. The cross-shore profiles are named as CSP-01 to CSP-81. CSP-01 corresponds to the southernmost profile which lies to the south of the existing Vizhinjam Harbour.

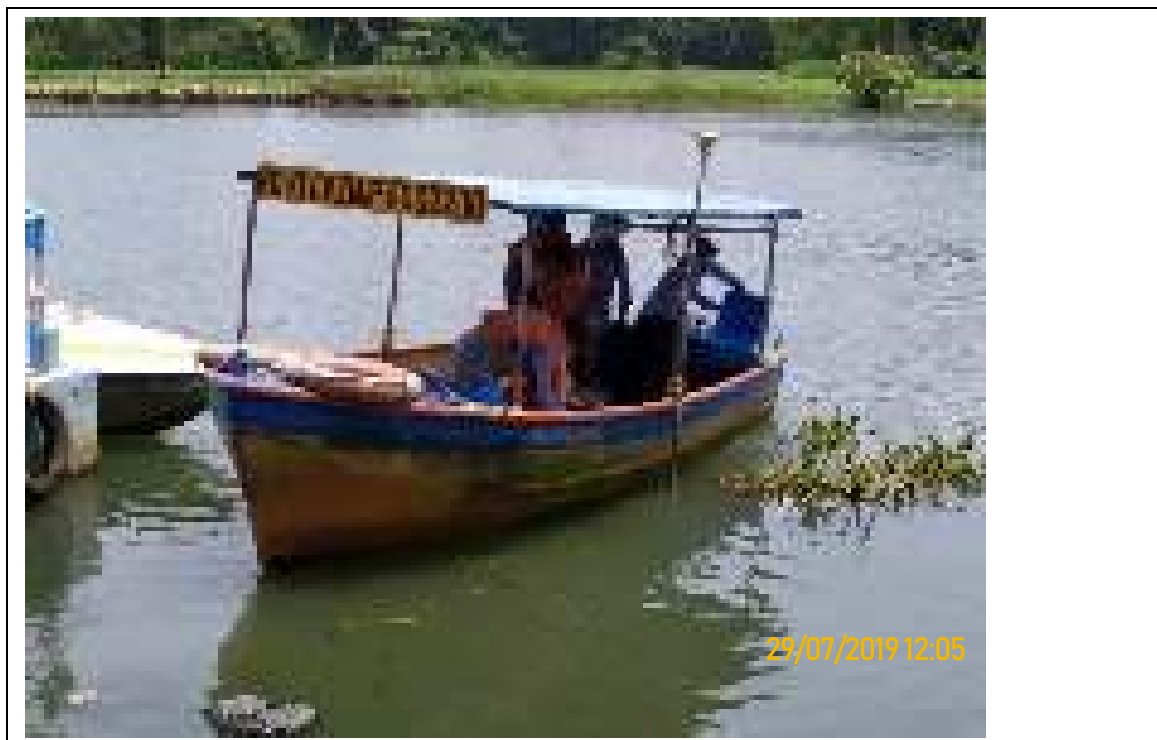
Figure 4-3: Survey Vessel M.V. Aruvi used at Veli Lake

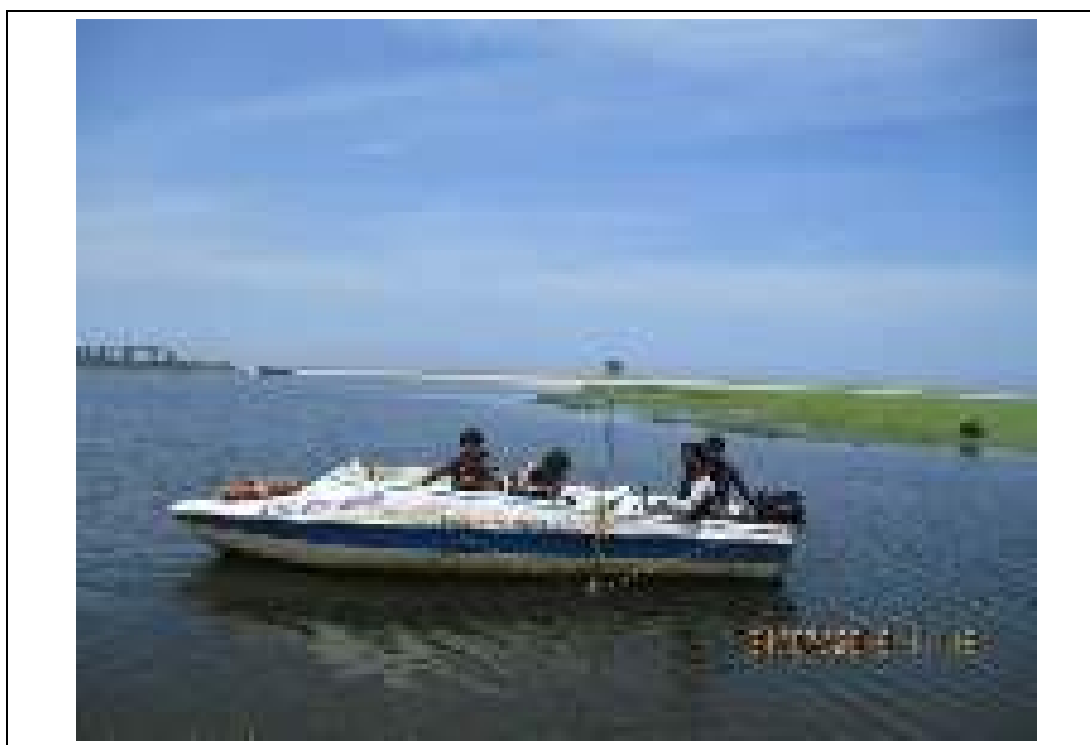
Figure 4-4: Survey Vessel used at Poovar, Chovara and Thiruvallam rivers

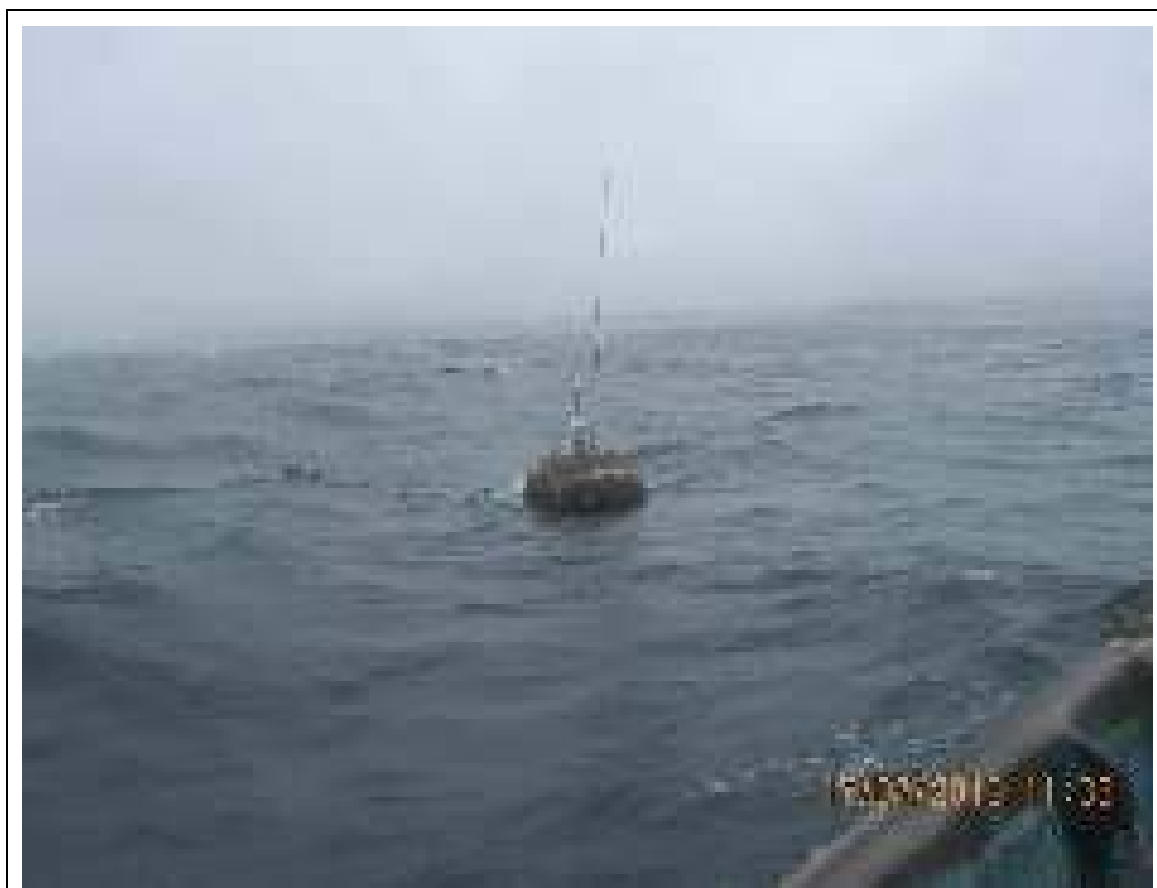
The image of WRB deployed at the location is provided below:

Figure 5-2: WRB deployed at site

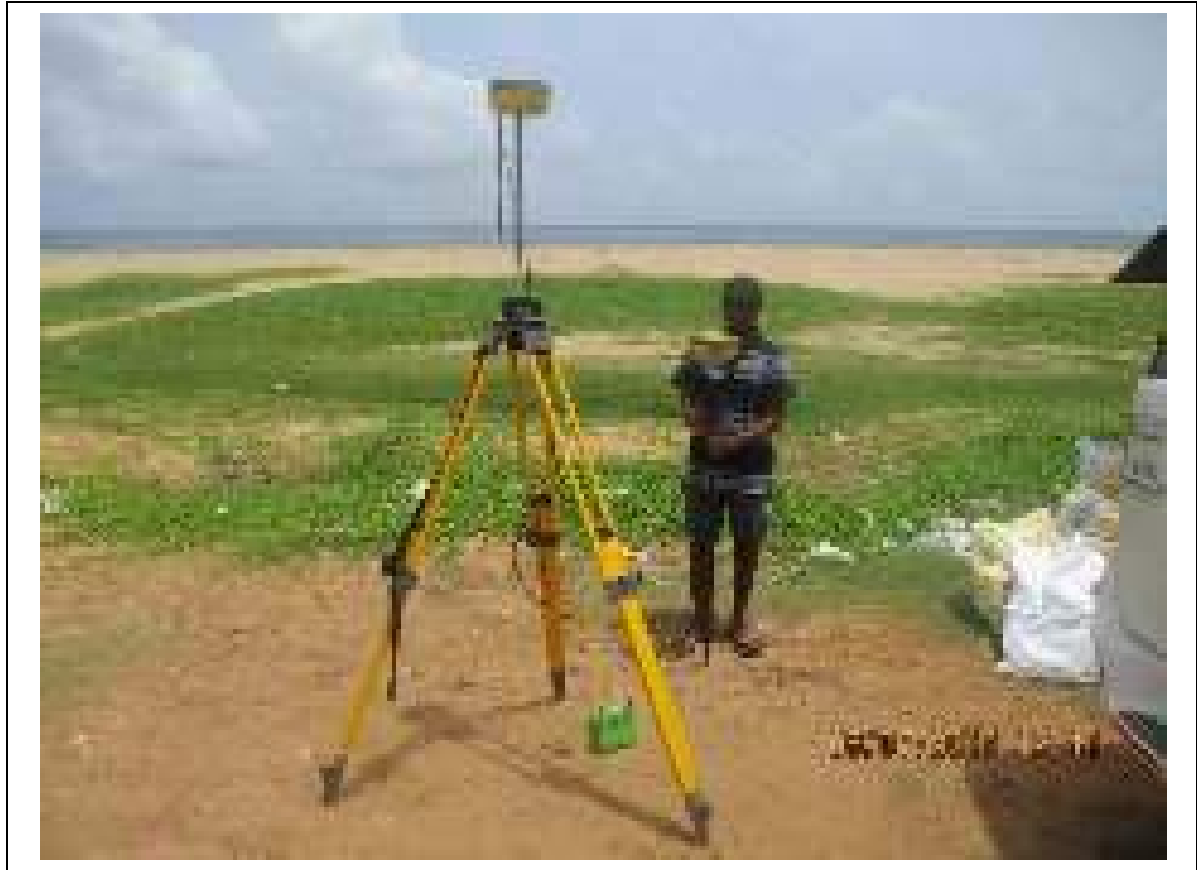
Figure 5-5: RTK System with base station and rover

An RTK system was mobilized at site to carry out cross-shore profiling on the landward side. The system used was a Geomax Zenith 10/20 RTK system with base station and rover. A photograph of the system is provided below:
