Sub: Half yearly Compliance report of Environmental and CRZ clearance for Vizhinjam International Multipurpose Deepwater Seaport for the period of **April 2019 to September 2019** – Reg.

Adani Vizhinjam Port Private Ltd	From : April 2019 To : September 2019
Vizhinjam International Deepwater Multipurpose Seaport Status of Conditions Stipulated in Environmental and CRZ Clearance

Half Yearly Compliance Report on Conditions Stipulated in Environmental & CRZ Clearance

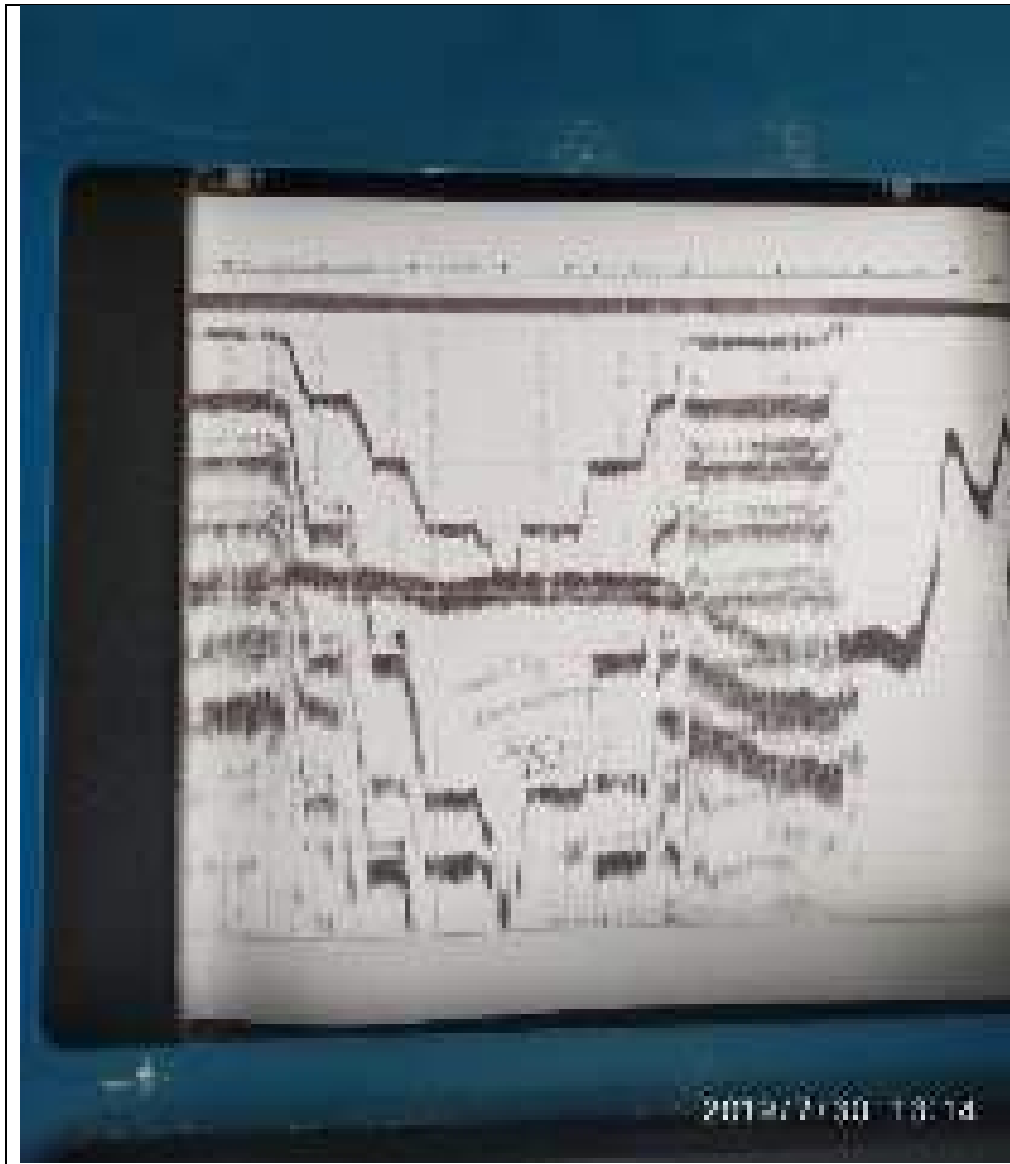
Figure 5-6: Bar check carried out on Syqwest Bathy 500 MF single beam echo sounder

A SyQuest Bathy 500 MF single beam echo sounder was used to carry out bathymetric survey of 4 river sections, namely, Chovara River, Veli River, Poovar River and Thiruvallam River. A photograph of the echo sounder system mobilized in the boat and the calibration carried out by the 'bar-check' method is shown below.

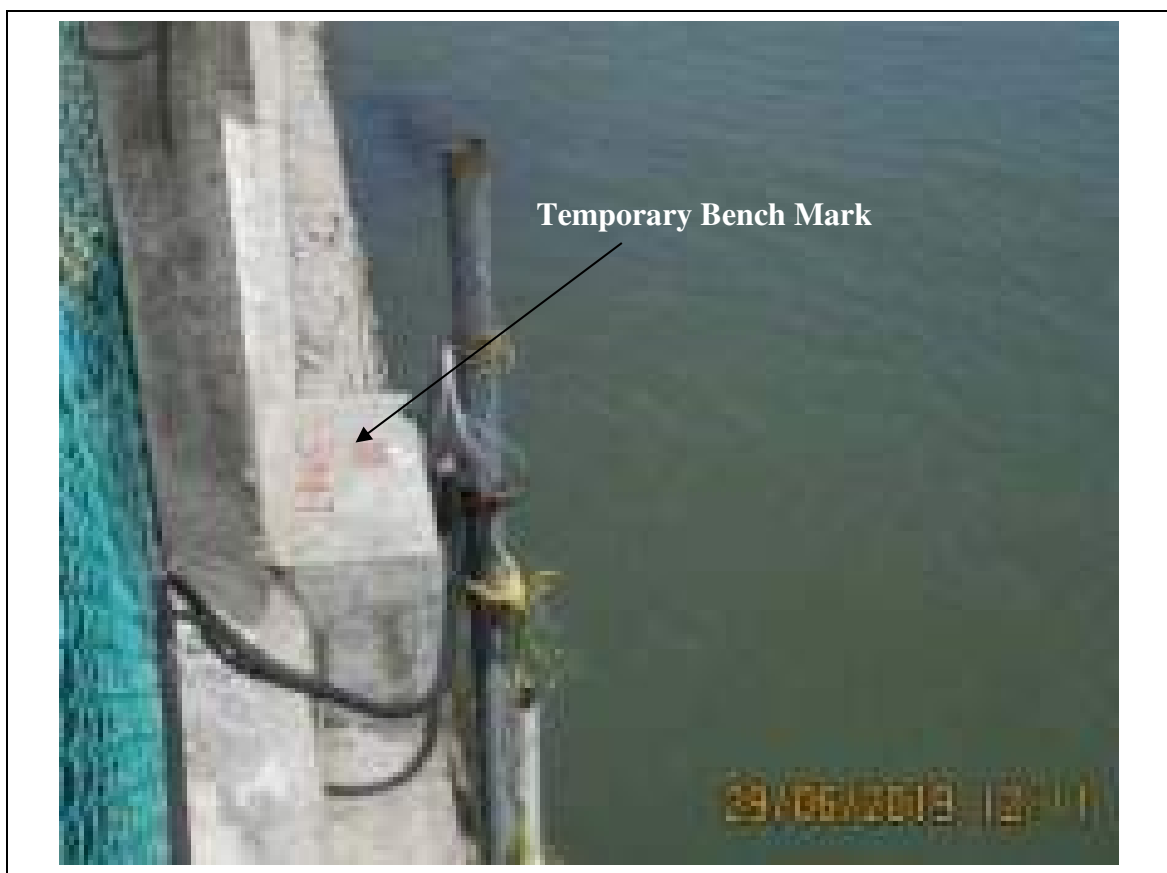
The tides were observed near the Coast Guard jetty. The tide is referenced to the chart datum, the value of which was provided by VISL. The temporary benchmark is marked on the wharf and is 3.447 above chart datum. An image of the TBM is provided below:

Figure 6-1: Location of TBM

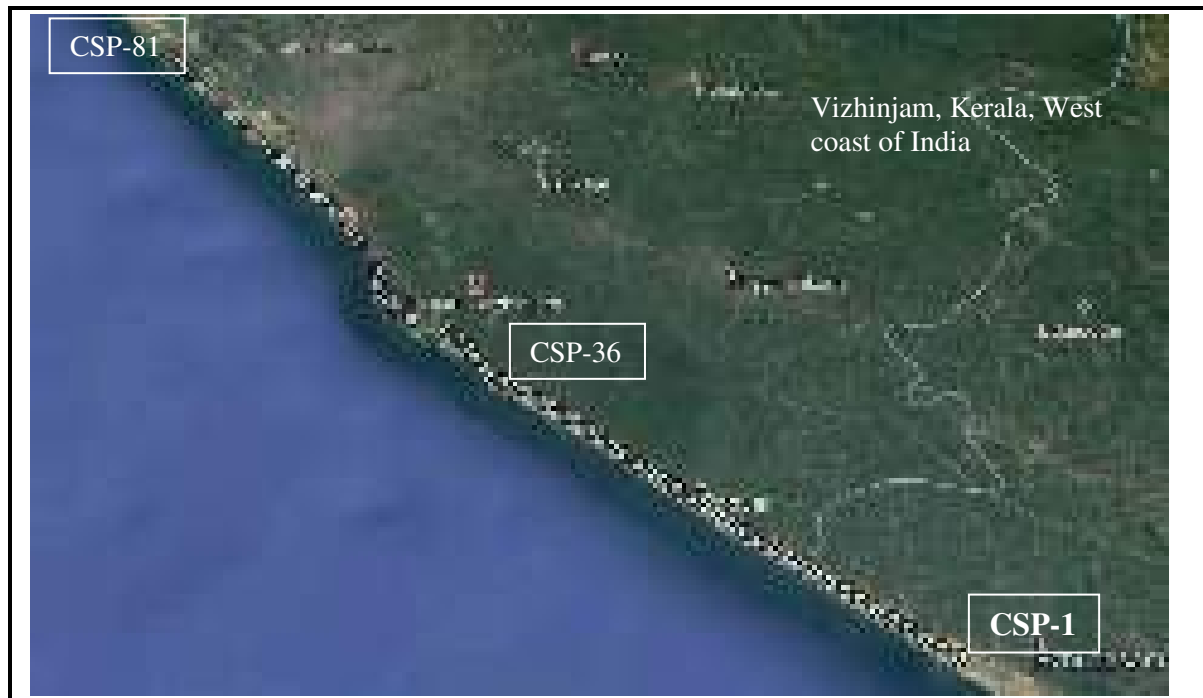
Figure 2-2: CSP, LEO and Photographic Documentation Locations

- ① The cross-shore profiling (CSP) lines, which coincides with the LEO, beach sampling and photographic documentation, are indicated in the image below. The cross-shore profiles are named as CSP-01 to CSP-81. CSP-01 corresponds to the southernmost profile which lies to the south of the existing Vizhinjam Harbour and gradually increases progressing towards north for the entire 40 km stretch (20 km on either side of the port) with a 500 m interval between each CSP line.

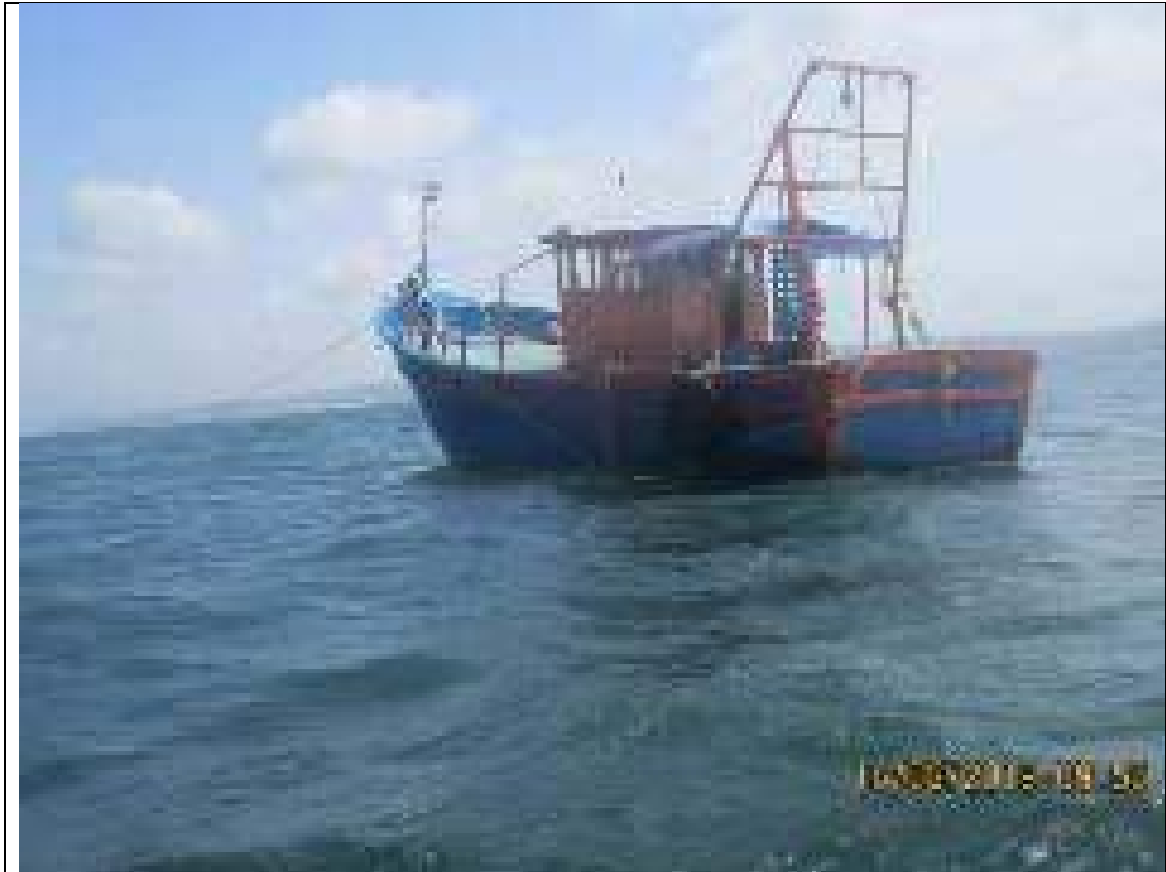
Figure 4-1: Watch keeping vessel MFB Samuel

The following vessel was utilized for the survey operation:

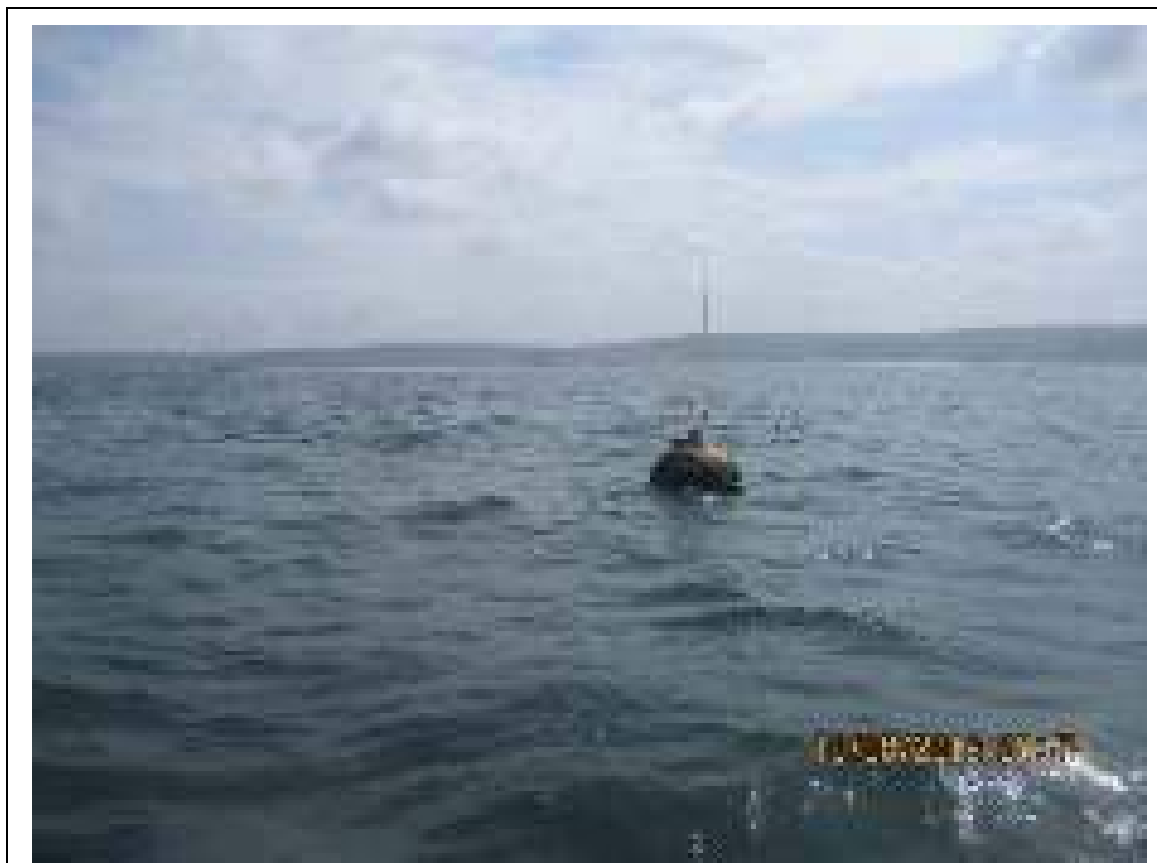
Figure 5-2: WRB deployed at site

The image of WRB deployed at the location is provided below:

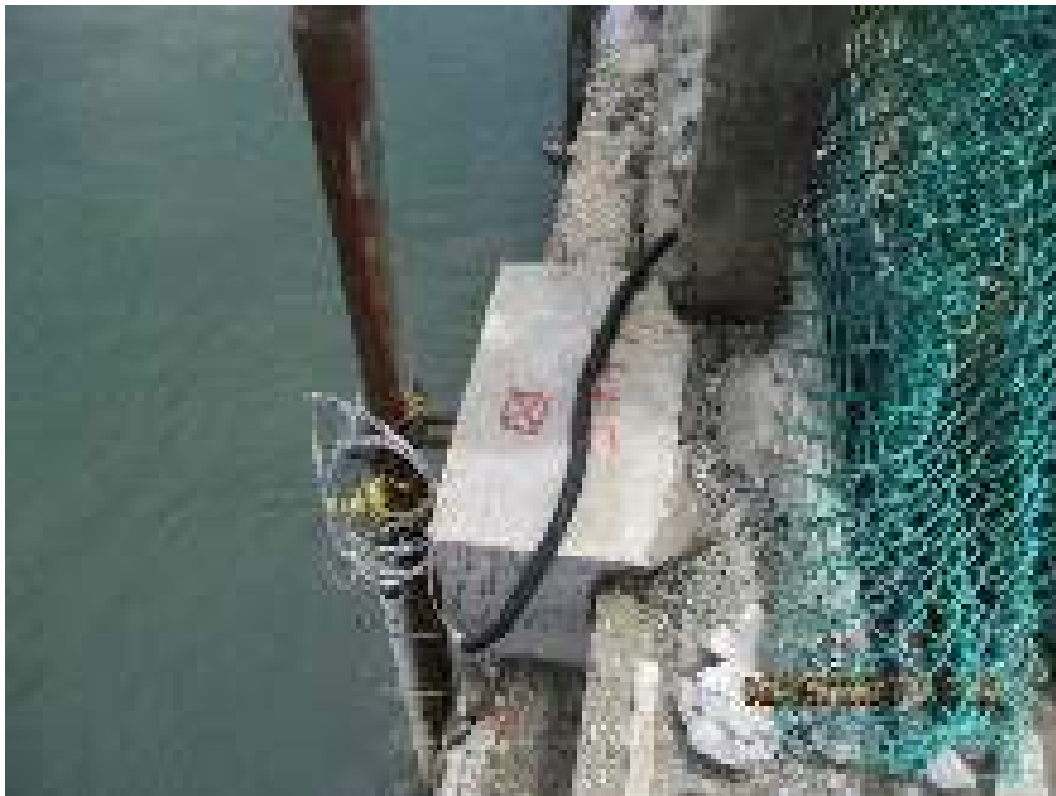
Figure 5-3: Tide Gauge

An EMCON automatic tide gauge was installed near the Coast Guard jetty, inside the fishing harbour for measuring the tides. The tide gauge is a capacitance-based instrument, measuring the water level due to change in capacitance on the surface of sensor. The sensor was installed on a 2.5m long pipe to ensure that the zero of sensor is always in water, irrespective of the phases of tide. This was levelled to the local benchmark, situated on top of the jetty. The tide station was programmed to measure the tide at 5-minute intervals throughout the duration of the project.

A photograph of the tide gauge location is provided below:

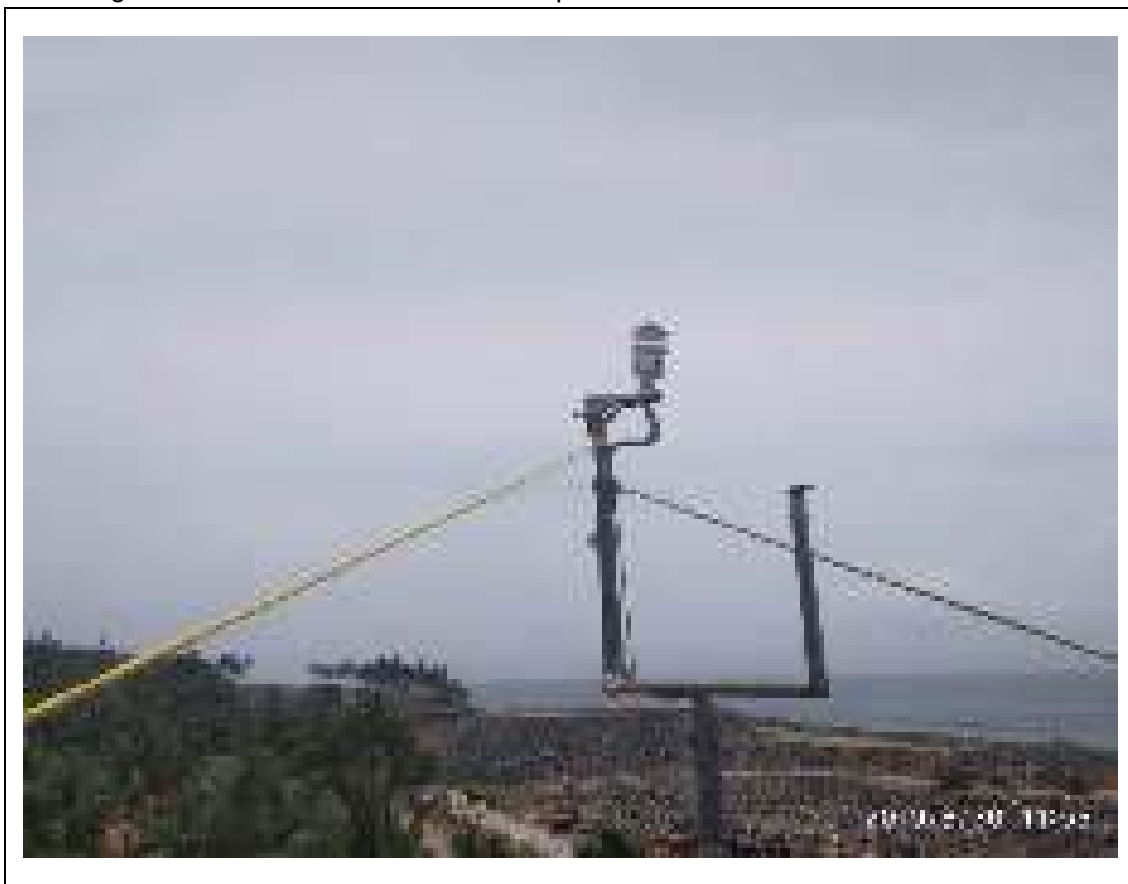
Figure 5-4: AWS on toop of Ayur Bay Resort, Nellikunnu (Mulloor)

The data is logged in a data logger installed at the receiving station at intervals of 10 minutes. The data is also transmitted from the data logger to a cloud bases server for further processing and QC checks.

An image of automatic weather station is provided below:

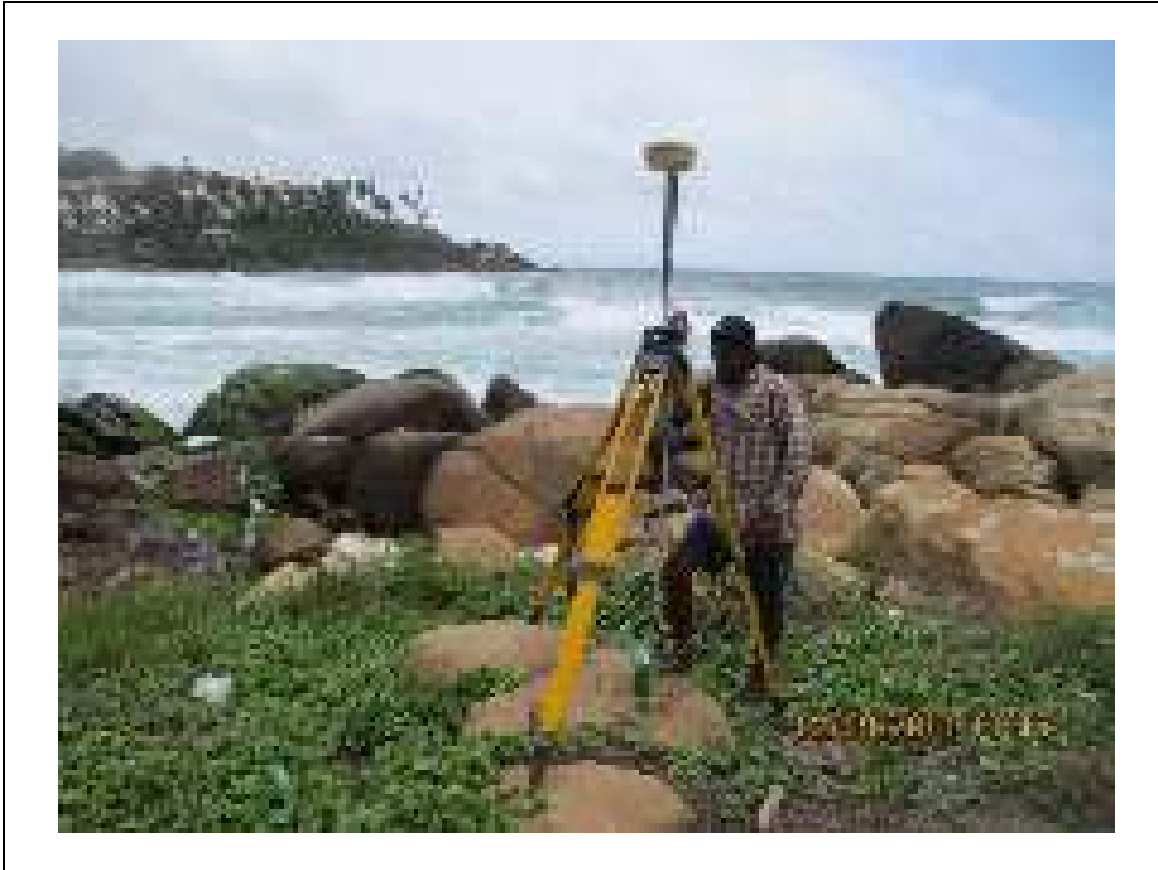
Figure 5-5: RTK System with base station and rover

An RTK system was mobilized at site to carry out cross-shore profiling on the landward side. The system used was a Geomax Zenith 10/20 RTK system with base station and rover. A photograph of the system is provided below:

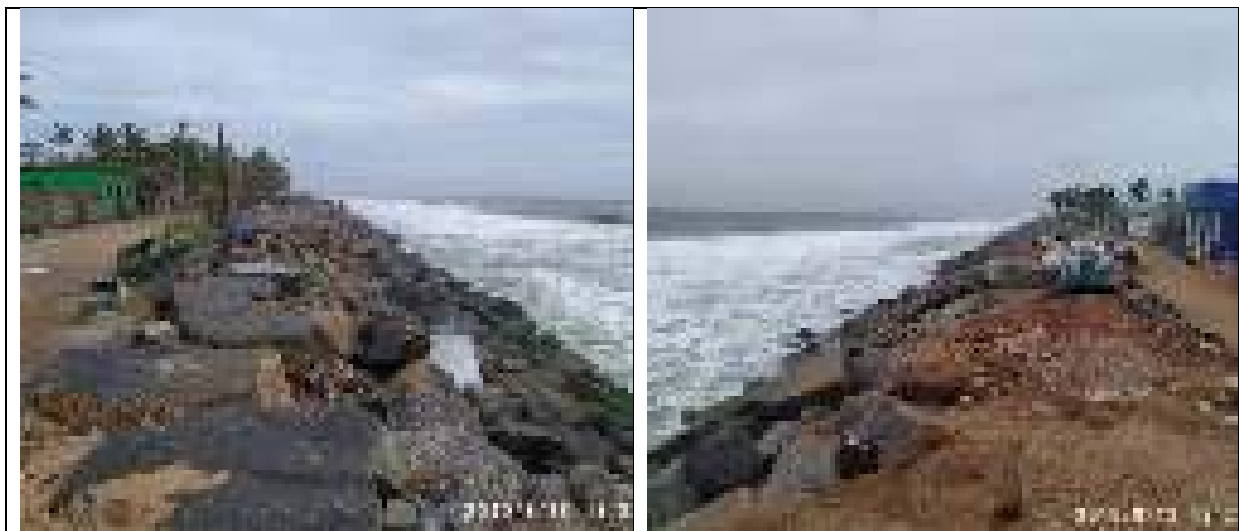
Figure 6-10 – CSP 10 (Pozhiyoor)

Photographic documentation was carried out for all the 81 locations, coinciding with the cross-shore profiling. The photographs for the period are placed at Annexure I. As a common reference point, a flag was fixed at each of the cross-shore profiling alignments while taking the photograph. Using the RTK system, this point was staked during the photography. As the monsoon commenced, the beaches were almost inundated with sea water and vast stretches of the shoreline were engulfed by waves. Few photographs of location where the beaches were not present during the season, are given below for reference:

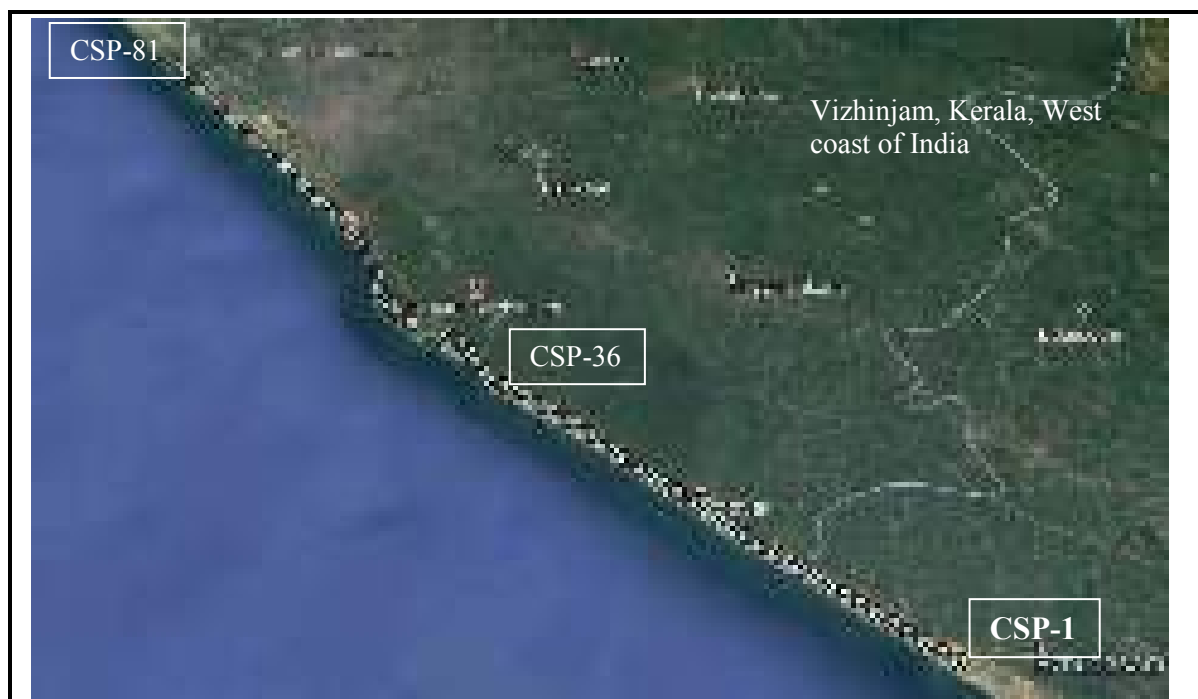
Figure 2-2: CSP, LEO and Photographic Documentation Locations

The cross-shore profiling (CSP) lines, which coincides with the LEO, beach sampling and photographic documentation, are indicated in the image below. The cross-shore profiles are named as CSP-01 to CSP-81. CSP-01 corresponds to the southernmost profile which lies to the south of the existing Vizhinjam Harbour and gradually increases progressing towards north for the entire 40 km stretch (20 km on either side of the port) with a 500 m interval between each CSP line.

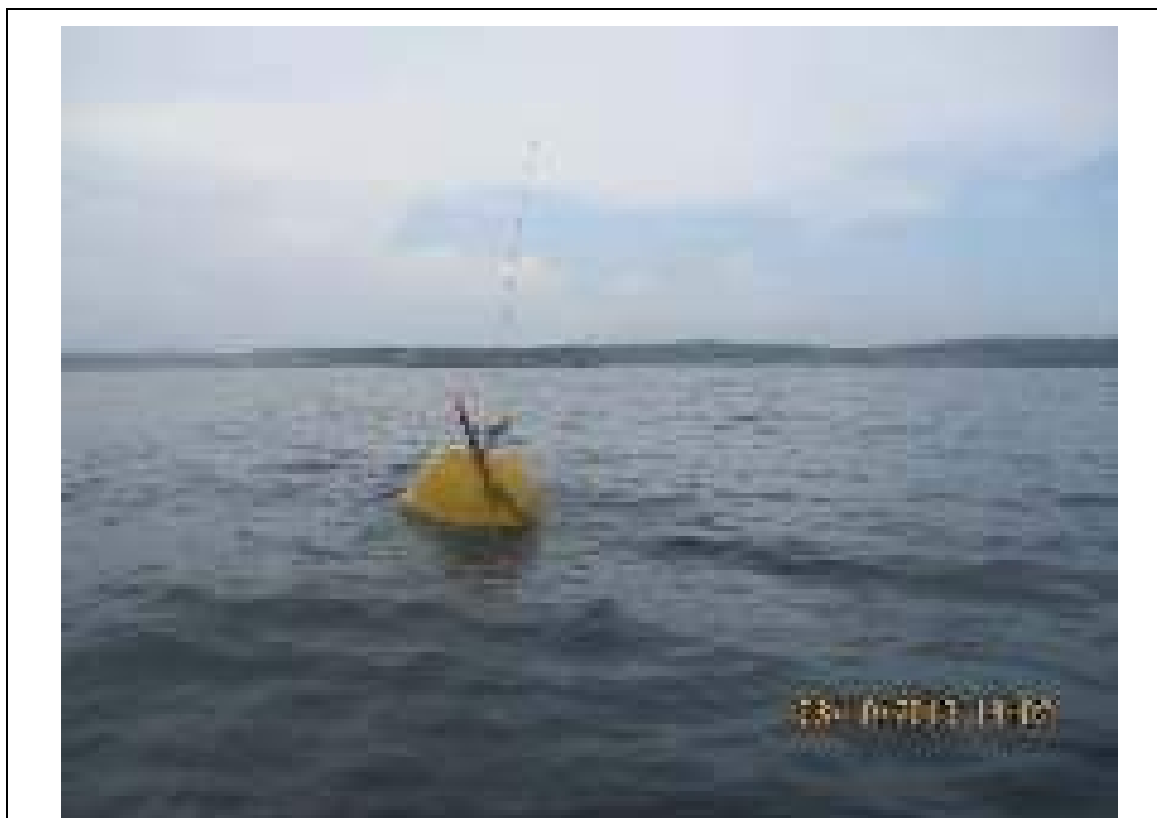
Figure 5-2: WRB deployed at site

The image of WRB deployed at the location is provided below:

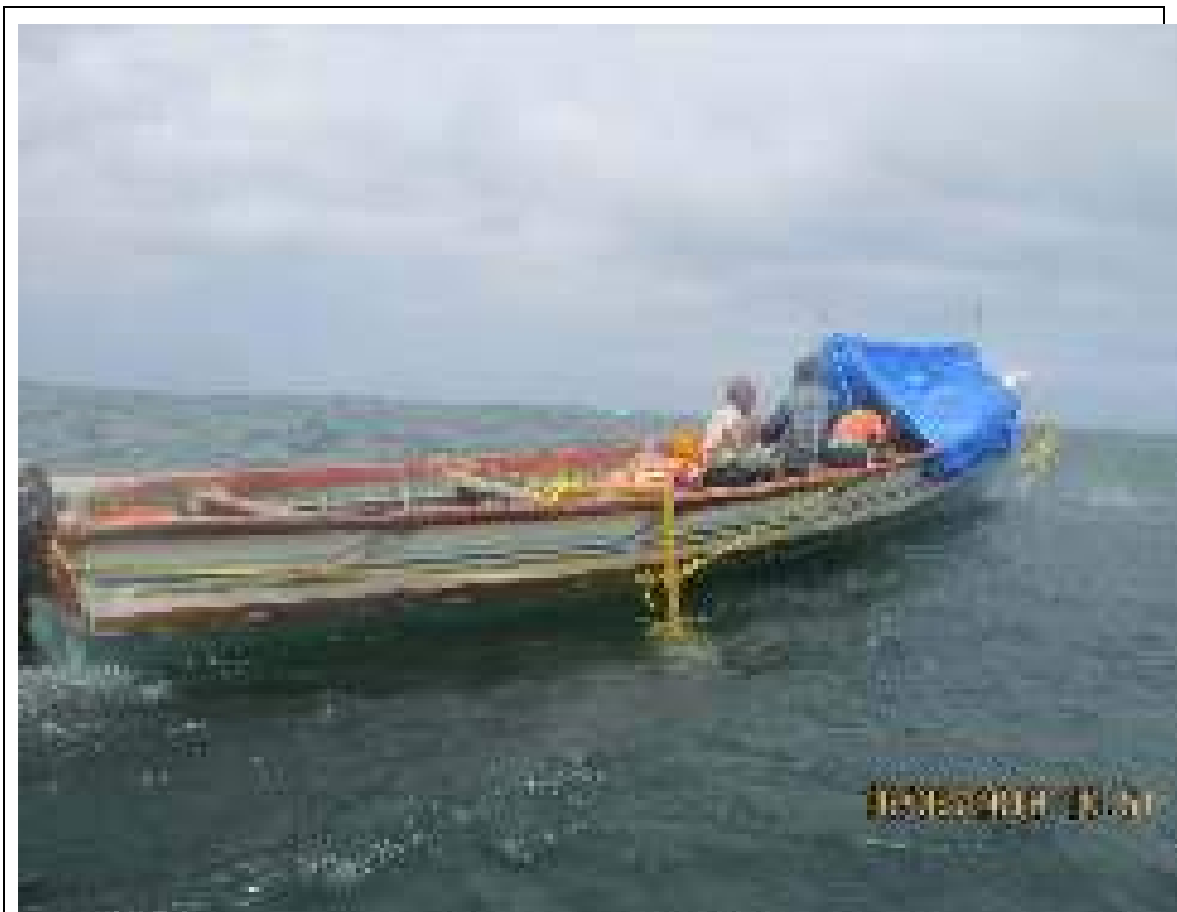
Figure 5-3: ADCP deployed at Vizhinjam

4 Teledyne Workhorse Sentinel 600 KHz Acoustic Doppler Current Profilers (ADCP) were installed at locations P1, P2, P3 and P4, namely, Vizhinjam, Poovar, Pachalloor and Mulloor. The current meters were installed in a downward looking mode. The current speed and direction were measured at intervals of every 10 minutes from surface to seabed at every 1m bin. Data from three various depths i.e. at the surface, mid-depth and bottom at each location are provided in the report. The following figure shows the ADCP installation on the vessel at various locations.

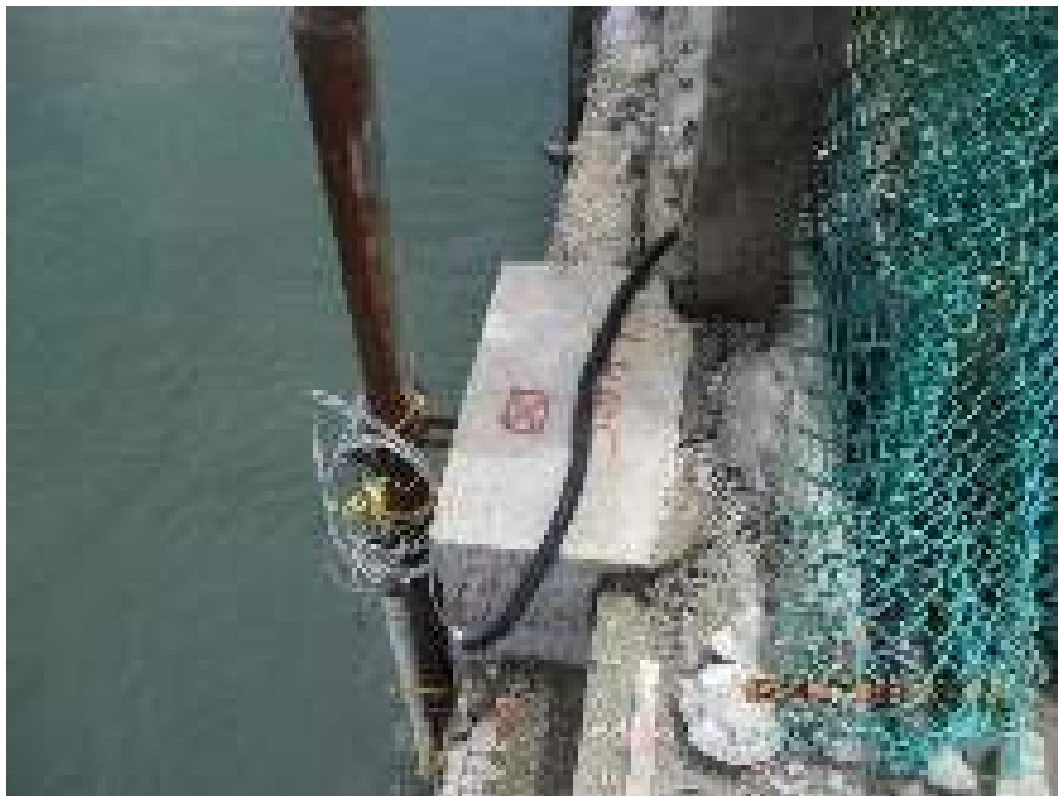
Figure 5-6: Tide Gauge

An EMCON Automatic Tide Gauge (ATG) was installed near the Coast Guard jetty, inside the fishing harbour for measuring the tides. The tide gauge is a capacitance-based instrument, measuring the water level due to change in capacitance on the surface of sensor. The sensor was installed on a 2.5m long pipe to ensure that the zero of sensor is always in water, irrespective of the phases of tide. This was levelled to the local benchmark, situated on top of the jetty. The tide station was programmed to measure the tide at 5-minute intervals throughout the duration of the project.

A photograph of the tide gauge location is provided below:

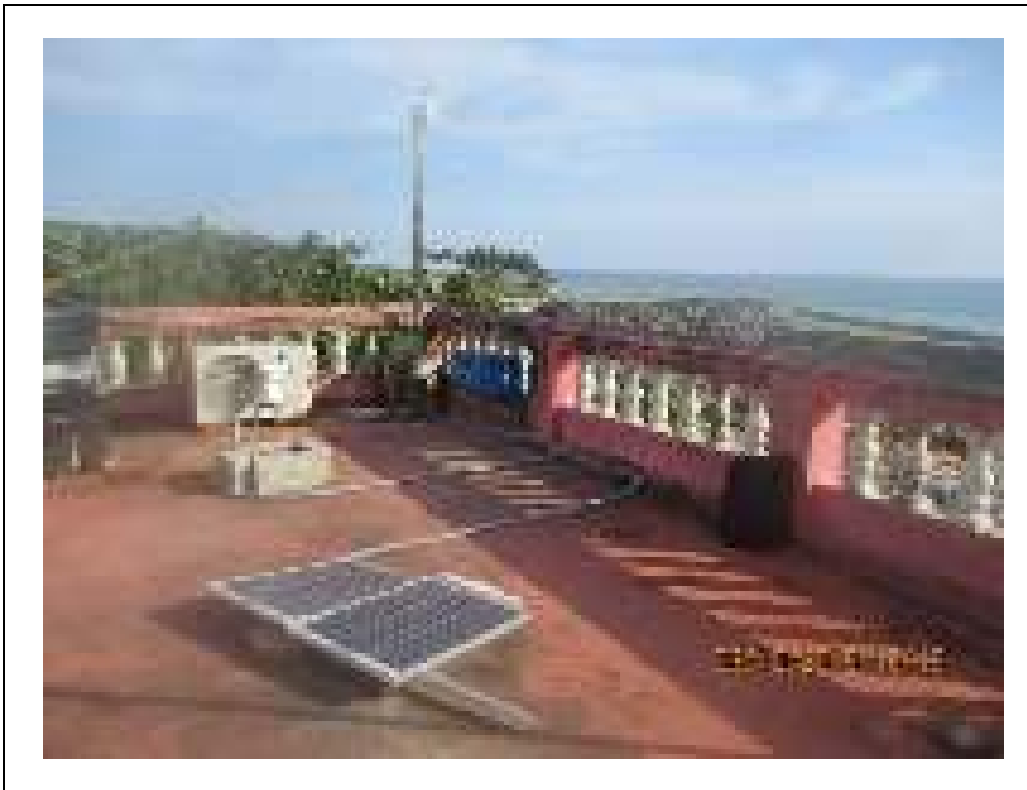
The data is logged in a data logger installed at the receiving station at intervals of 10 minutes. The data is also transmitted from the data logger to a cloud based server for further processing and QC checks.

Figure 5-7: AWS on toop of Ayur Bay Resort, Nellikunnu (Mulloor)

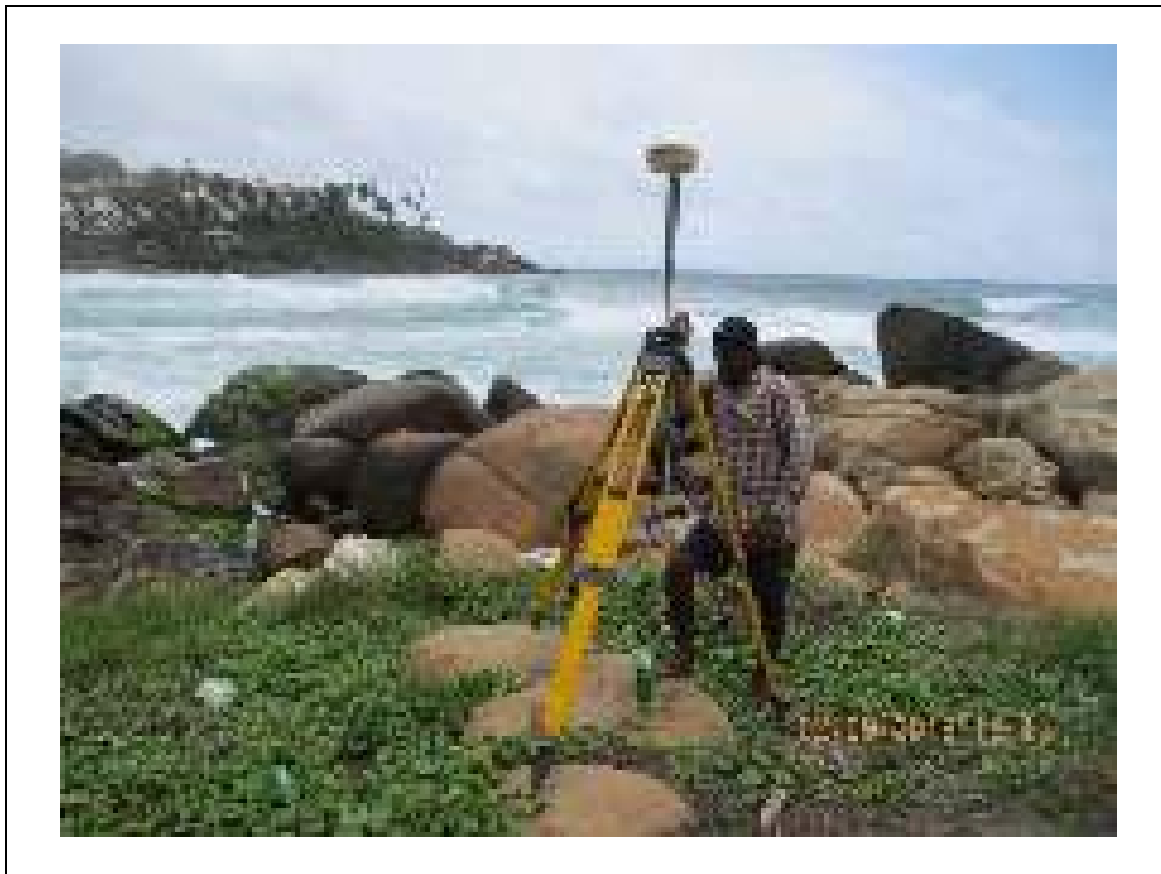
An RTK system was mobilized at site to carry out cross-shore profiling on the landward side. The system used was a Geomax Zenith 10/20 RTK system with base station and rover. A photograph of the system is provided below:

Figure 5-8: RTK System with base station and rover

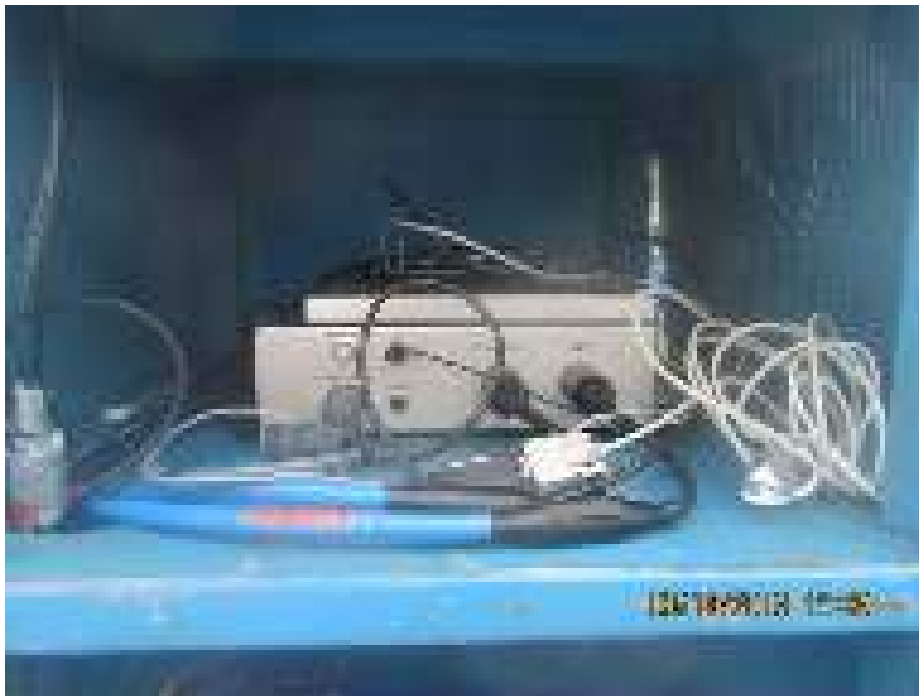
A GeoAcoustics Geoswath Plus Multibeam Echo Sounder, operating at a frequency of 500 kHz, was used to delineate the topography of the seabed. The measured sound velocity and observed tide was fed into the system during data processing.

Figure 5-9: Multibeam echo sounder deck unit

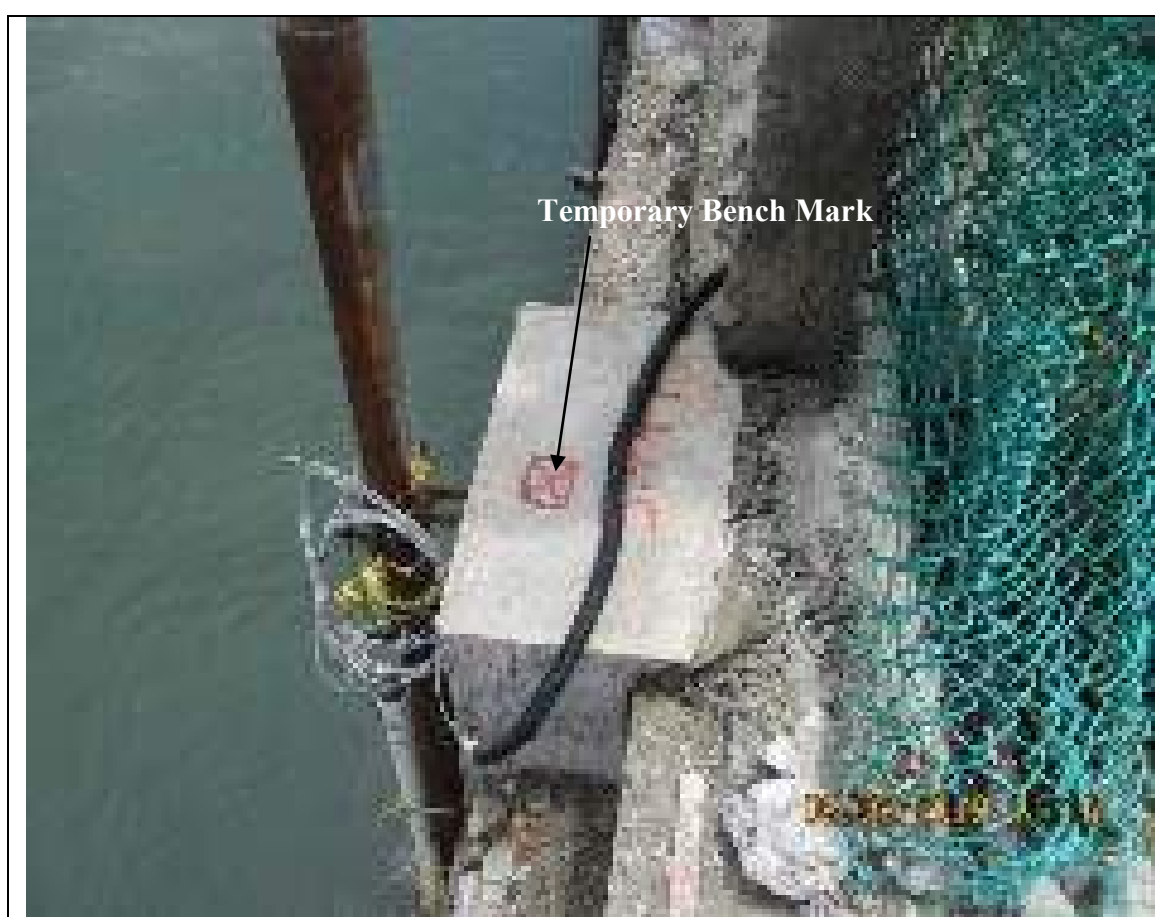
The tides were observed near the Coast Guard jetty. The tide is referenced to the chart datum, the value of which was provided by VISL. The temporary benchmark is marked on the wharf and is 3.447m above chart datum. An image of the TBM is provided below:

Figure 6-1: Location of TBM

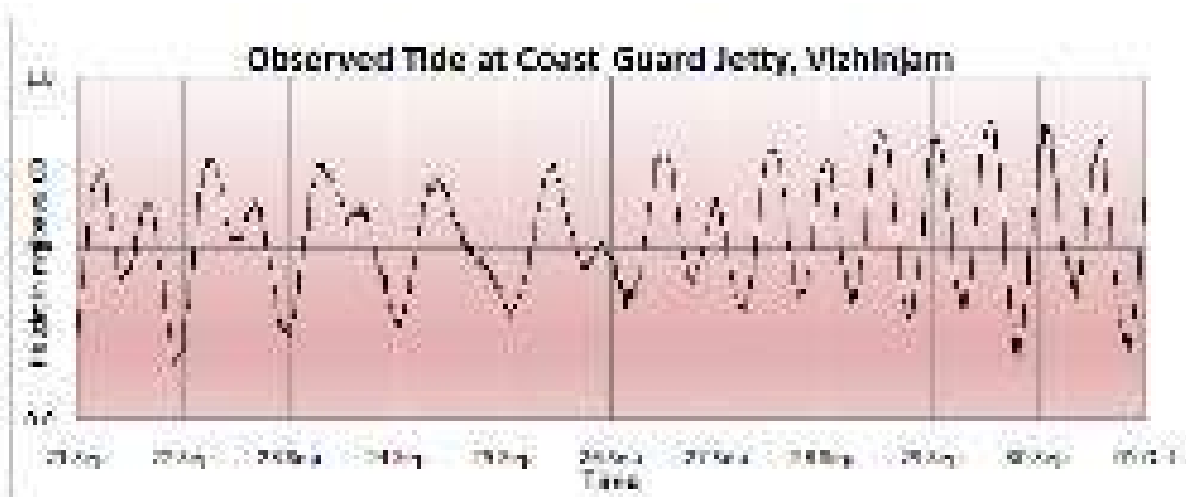
The tides observed are mixed semi-diurnal in nature, with the maximum range of 0.92m being observed in the springs. The representation of tide data collected, in the form of graphs is placed below.

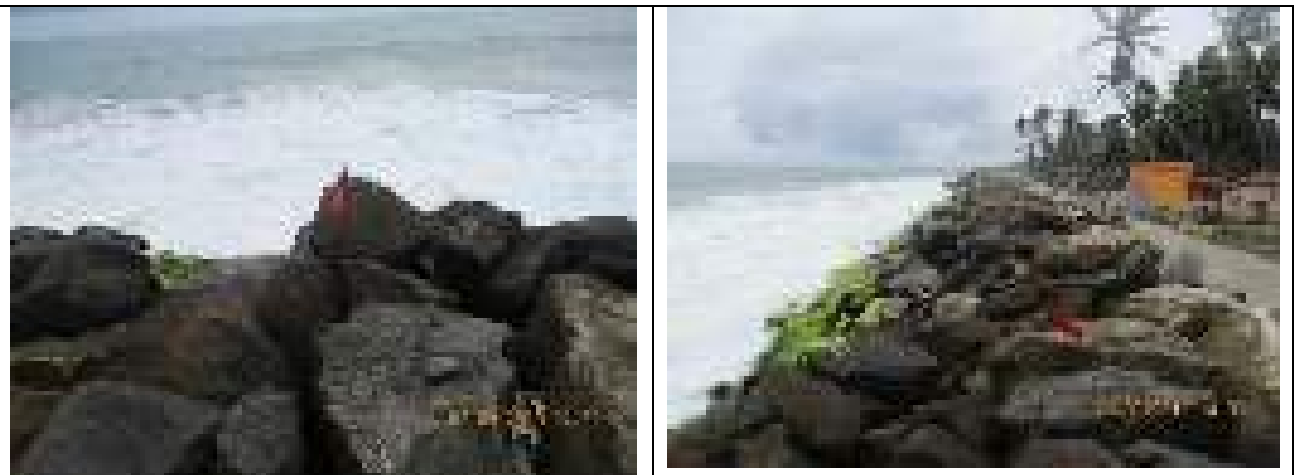
Few photographs of location where the beaches were not present during the season, are given below for reference:

Figure 6-36: CSP 50 (Panathura Temple)

Photographic documentation was carried out for all the 81 locations, coinciding with the cross-shore profiling. The photographs for the period are placed at Annexure I. As a common reference point, a flag was fixed at each of the cross-shore profiling alignments while taking the photograph. Using the RTK system, this point was staked during the photography. As the monsoon was active during the observation period, the beaches were almost inundated with sea water and vast stretches of the shoreline were engulfed by waves.

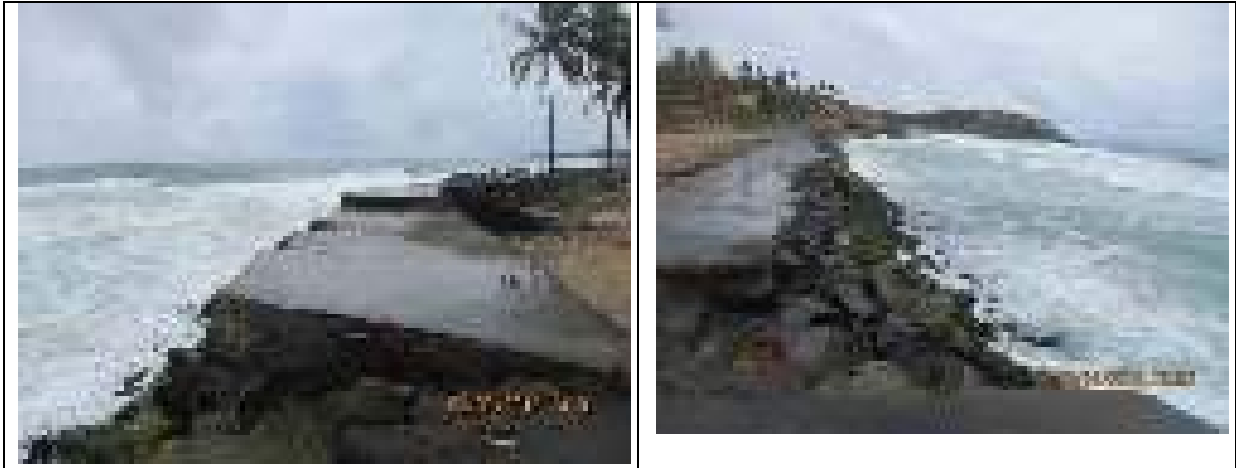
Figure 6-37: CSP 47 (Samudra Beach, Kovalam)

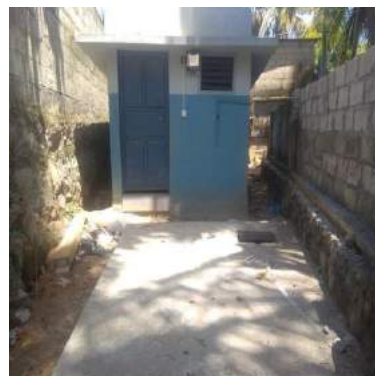
4.2 Public toilet at Kottappuram

The construction of public toilet at Kottappuram has been completed. Construction of Septic tank and laying of pipeline are about to complete. Presently 95% of the work completed.

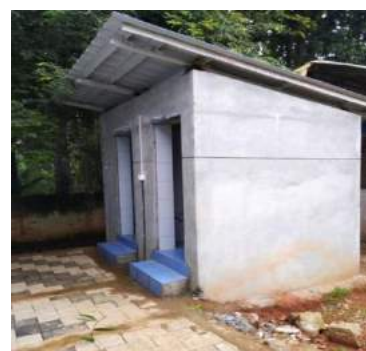
4.3 Toilet for teachers, Ayyankali Smaraka UP School, Venganoor

The construction of toilet for teachers is progressing at Ayyankali School. Almost 80% of works completed. Plumbing and finishing work are going on. Last year one toilet block was constructed for the students of the school.

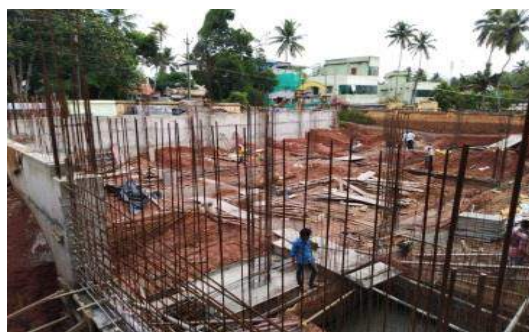
4.4. Community Health Centre, Vizhinjam

The construction of new building at Community Health Centre, Vizhinjam is progressing. Almost 10% of works completed. Harbour engineering department is executing and monitoring the work. Adani

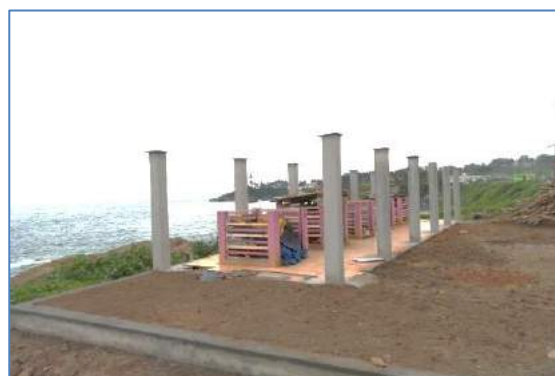
4.5 Roofing of Thumboormuzhi aerobic bin at Harbour

The roofing of Thumboormozhi having 10 Aerobins at Harbour ward has been started. It is a work costing Rs.10 lakhs. Once the work is completed, would support around 1000 families in the vicinity to dispose their organic waste. The work has been appreciated by Trivandrum Municipal Corporation and the print medias.

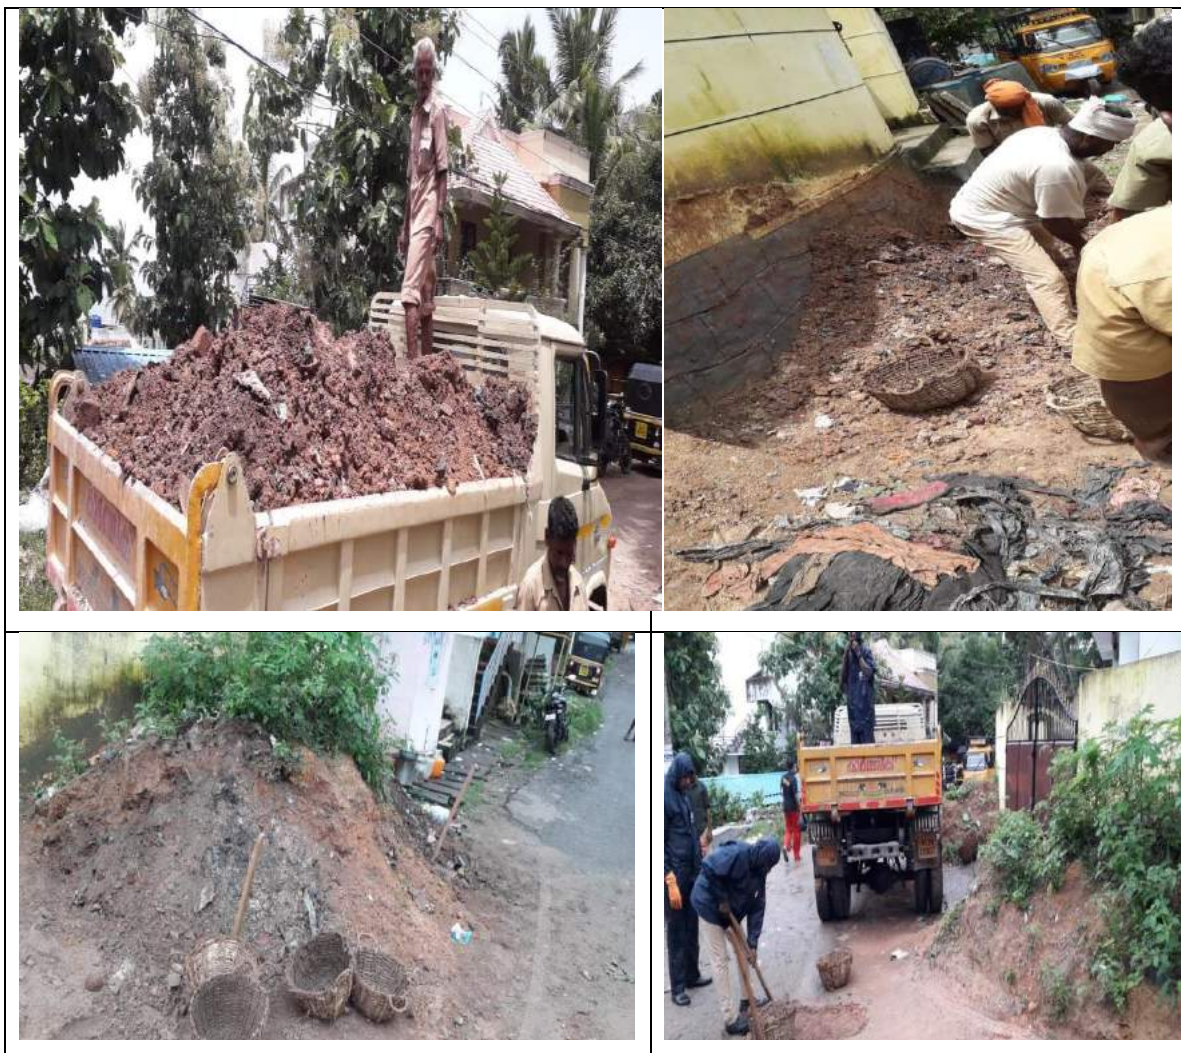
The debris remained after the civil work for the Toilet block construction at Kottappuram was making problem to the free flow of water. Localites requested to remove it and the same has been cleared with the help of Corporation Cleaning staff.

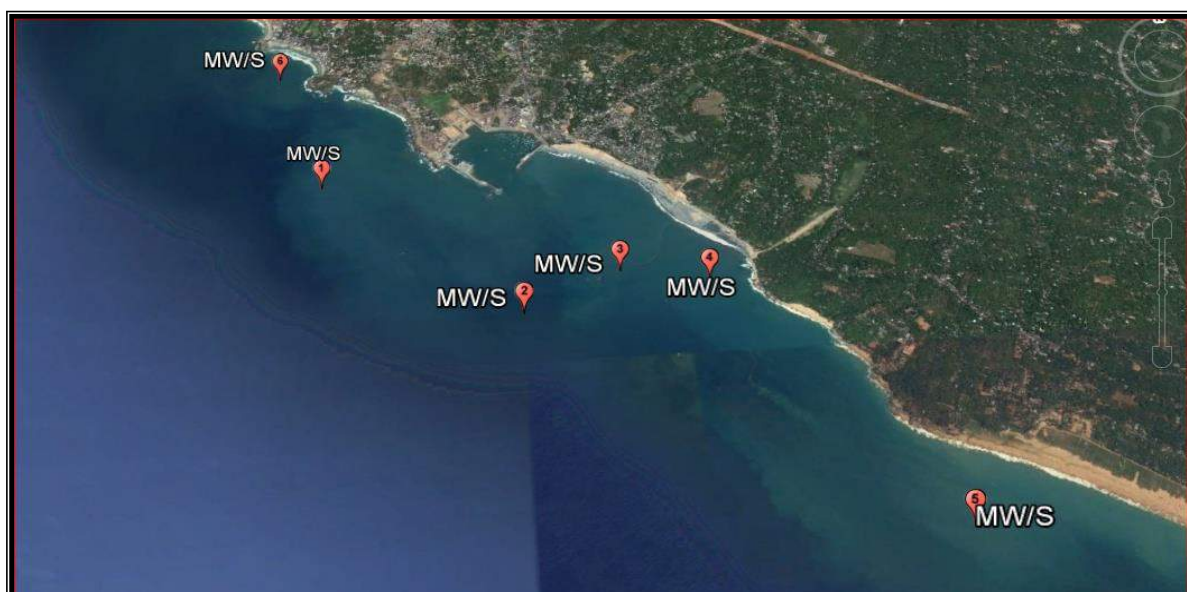
Figure 5.1 Google earth view of Marine Water and Sediment Sampling Locations

Table 5.1 Marine Water and Sediment sampling locations details

Sr. No.	Location	Latitude	Longitude
1.	Near Kovalam Beach	8°22',28.20" N	76°58',48.70" E
2.	Proposed Dredge Material Disposal Site	8°21',54.40" N	76°59',27.90" E
3.	South of Break Water	8°22',03.20" N	76°59',46.50" E
4.	Port Basin	8°22',00.00" N	77°00',03.30" E
5.	Inner Approach Channel	8°21',05.90" N	77°00',40.70" E
6.	Kovalam Beach	8°23',03.61" N	76°58',37.62" E
