Vizhinjam International Seaport Limited (A Government of Kerala Undertaking)

Sub: Half Yearly Compliance Report [HYCR] of Environmental and CRZ Clearance for Vizhinjam International Multipurpose Deepwater Seaport for the period of April 2020 to September 2020 – Reg.

Half Y	Half Yearly Compliance Report (HYCR) on Conditions Stipulated in Environmental & CRZ Clearance (EC) F.No.11-122/2011-IA.III dated 03.01.2014 for the Period April 2020 to September 2020

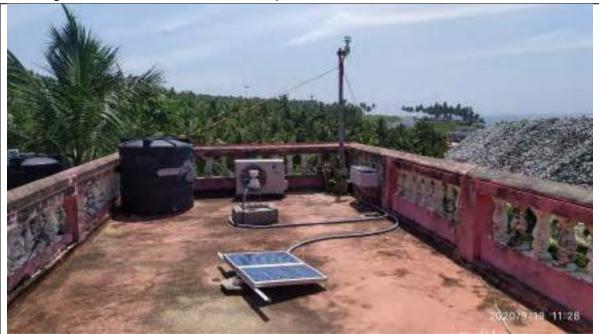
The data is logged in a data logger installed at the receiving station at intervals of 10 minutes. The data is also transmitted from the data logger to a cloud based server for further processing and QC checks.

An image of automatic weather station is provided below:

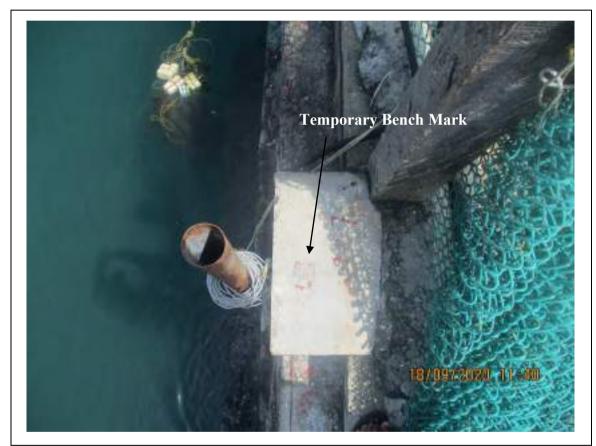
Figure 6-1: Location of TBM

The tides were observed near the Coast Guard jetty. The tide is referenced to the chart datum, the value of which was provided by VISL. The temporary benchmark (TBM) is marked on the wharf and is 3.447m above chart datum. An image of the TBM is provided below:

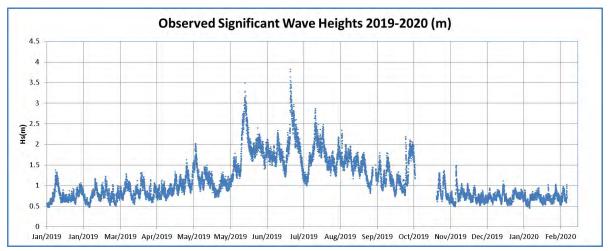
Figure 2-3 Time history plot of wave height for observed wave data

This section of the report mainly discusses about the wave parameters based on the observed wave data. Wave parameters were measured using WRB (Mulloor) at $08^{\circ}21'$ 43.15" N, 76°59'25.86" E (-23.2 m) during the period of 01^{st} March 2019 to 29^{th} February 2020. The measured wave height, direction and peak wave period are represented in the form of graphs and are given in Figure 2-3 to Figure 2-5.

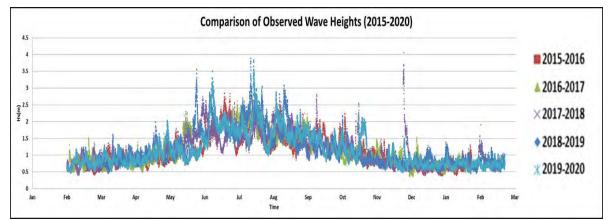
Figure 2-6 Comparison of wave heights (2015-2020)

Wave parameters were measured using WRB during the period of 10th February 2015 to 29th February 2020 by OSAS till June 2019 and later on by Shankar & Co. at the project location. A comparison for percentage exceedance of wave heights observed for the past four years from 2015, 2016, 2017, 2018 and 2019 was carried out and the same is presented in Figure 2-8. From these comparisons, it can be seen that the variability of wave heights and directions are similar for all the years except for storm events.

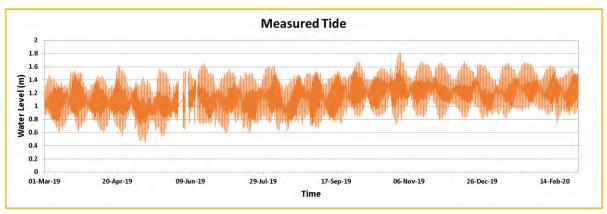
Figure 2-9 Tide data measured during Mar 2019 to Feb 2020

Subsequently, OSAS collected data, at 08° 22' 33.68" N, 76° 59' 16.65" E and at a depth of 3.3 m, for the period of March 2019 to June 2019 and Shankar & Co. collected data from July 2019 to February 2020. The measured tide provided by AVPPL is presented in Figure 2-9.

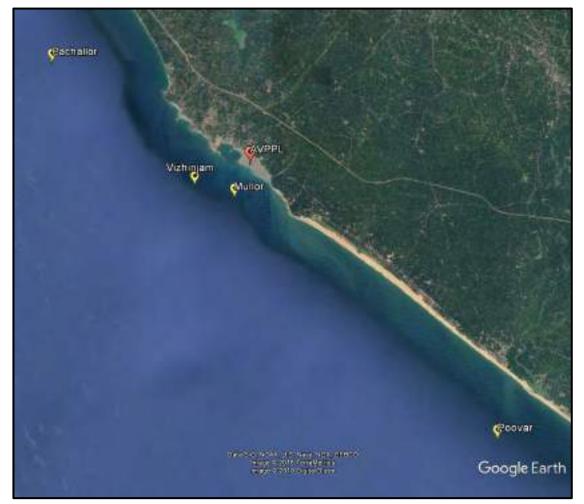
Figure 2-10 Locations from where the current data are collected
Table 2-2 Observed Current Speed and Direction during 2019

presented in Figure 2-10. AVPPL provided the current data for one month for each season from March 2019 to February 2020 (Pre-monsoon, Monsoon and Post-monsoon). The data collected for each season are presented in Figure 2-19 and Figure 2-34.

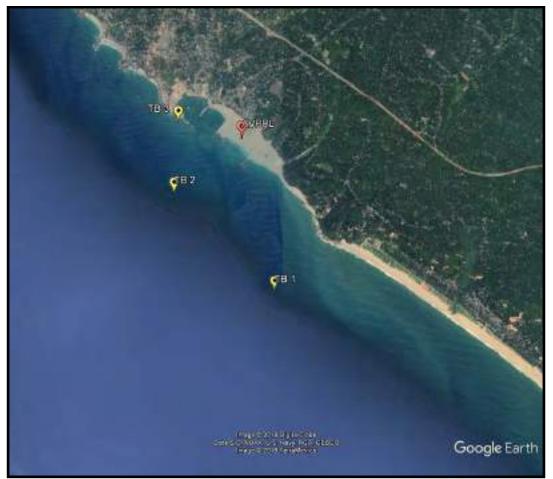
Figure 2-38 Location of Turbidity Buoys

AVPPL has provided the turbidity data from 1st March 2019 to 29th February 2020 in 10 min intervals collected from three locations near the port area as presented in Figure 2-38 using turbidity monitoring buoys.

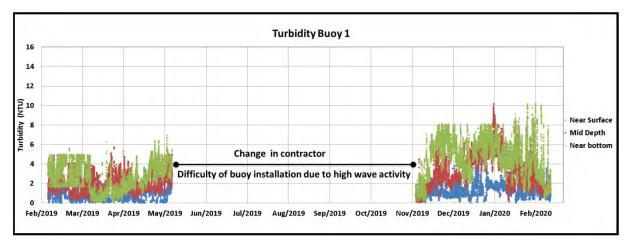
Figure 2-39 Time series plotted with the turbidity data collected from Turbidity Buoy 1

The time series plotted using this turbidity data are presented in Figure 2-39 to Figure 2-41 for all the three locations. It has been informed by the Client that all the three buoys were non-operational from June 2019 to October 2019 due to change in contractor and difficulty in buoy installation during monsoon season. All turbidity values are found below 10 NTU.

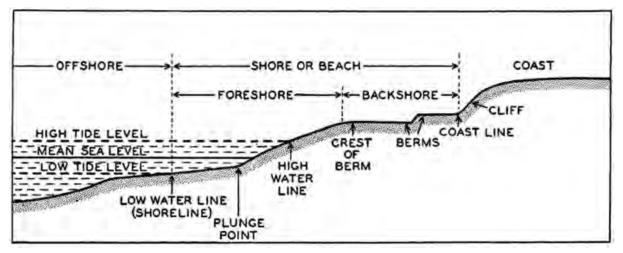
Figure 2-54 Beach profile terminology

Data gaps were observed at foreshore zone (as shown in Figure 2-54) due to inaccessible depths and rough weather condition during survey period. Data were not available from June 2019 to August 2019.

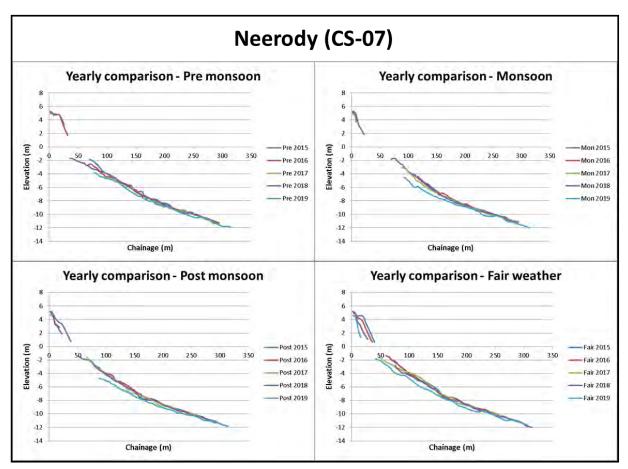
Figure 2-56 Profiles at Neerody (CS 07) – Yearly comparison

Coastal protection structure known as seawall was present in the stretch of CS 3 to CS 9. Among these sections, CS 7 which is at Neerody location in Tamil Nadu state was chosen to illustrate the seasonal trends over five years. In this stretch, some construction activities (groins) were noticed during fair weather season of 2019. From Figure 2-55, it can be noticed that the seasonal variations are very minimal. However, accretion was observed in foreshore zone during Ockhi (December 2017).

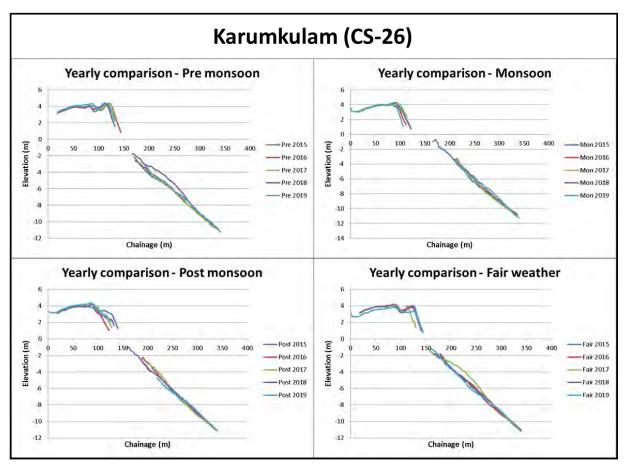
Figure 2-71 Profiles at Karumkulam (CS 26) – Yearly comparison

Beach was present throughout the year in the stretch of CS 18 to CS 34. Among these sections, CS 26 which is at Karumkulam location in Thiruvananthapuram district of Kerala state was chosen to illustrate the seasonal trends over five years. From Figure 2-70, it can be noticed that the coast undergoes seasonal variations during 2015 to 2019. Beach was noticed during pre-monsoon seasons. Later on beach got eroded and deposited in offshore region at the time of monsoon seasons. Beach gradually developed during post monsoon seasons and remained stable during fair weather seasons whereas in 2017 the coast experienced a very severe cyclonic storm (IMD Classification) named Ockhi (December 2017) during fair weather season and resulted in severe erosion all along the coast. After Ockhi the erosion was noticed during fair weather 2017 and pre monsoon 2018 seasons on land side. Recently, this has been compounded by the prevalence of the higher events related to storms.

The plots represent comparison of profiles of particular season over different years. These plots suggest that yearly trend was as per normal sequence till post monsoon 2017. After this, the impact of Ockhi cyclone can be evidently noticed in fair weather 2017 and premonsoon 2018 seasonal profiles. The coast was undergoing processes to recover from this impact which can be observed from fair weather seasons comparison plot.

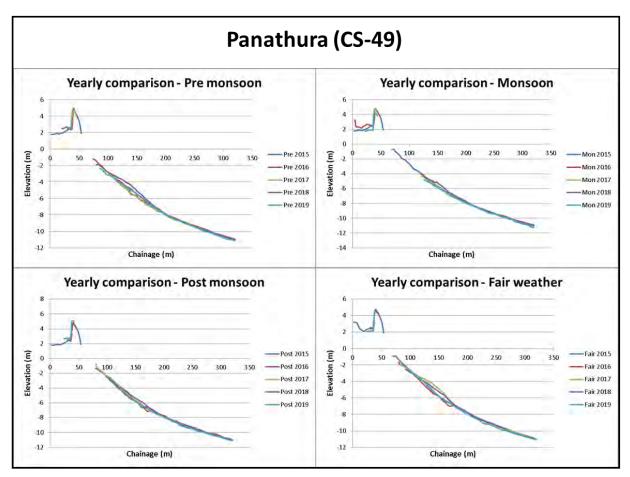
Figure 2-79 Profiles at Panathura (CS 49) – Yearly comparison

Coastal protection structure known as seawall was present in the stretch of CS 47 to CS 52. Among these sections, CS 49 which is at Panathura location in Thiruvananthapuram district of Kerala state was chosen to illustrate the seasonal trends over five years. From Figure 2-78, it can be noticed that the seasonal variations are very minimal. However, accretion was observed in foreshore zone during Ockhi (December 2017).

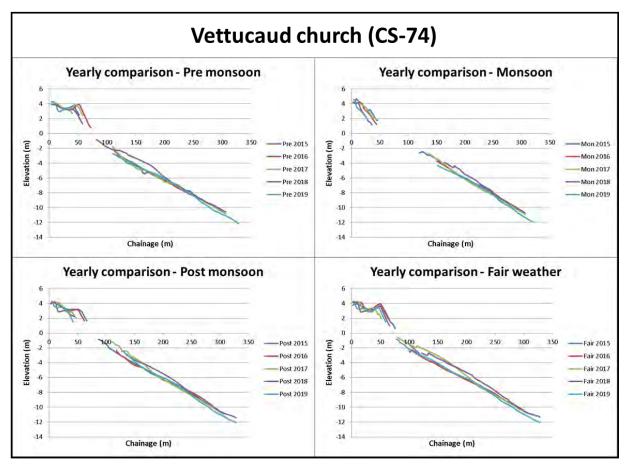
Figure 2-93 Profiles at Vettucaud (CS 74) – Yearly comparison

Beach was present throughout the year in the stretch of CS 68 to CS 81. Among these sections, CS 74 which is at Vettucaud location in Thiruvananthapuram district of Kerala state was chosen to illustrate the seasonal trends over five years. From Figure 2-92, it can be noticed that the coast undergoes seasonal variations during 2015 to 2019. Beach was noticed during pre-monsoon seasons. Later on beach got eroded and deposited in offshore region at the time of monsoon seasons. Beach was gradually developed during post monsoon seasons and remains stable during fair weather seasons whereas in 2017 the trend got shifted as the coast experienced a very severe cyclonic storm (IMD Classification) named Ockhi during fair weather season resulted in severe erosion all along the coast and accretion was observed in foreshore zone. After Ockhi the erosion was noticed during fair weather 2017 and pre monsoon 2018 seasons on land side and deposition on sea side.

The plots represent comparison of profiles of particular season over different years. These plots suggest that yearly trend was as per normal sequence till post monsoon 2017. After this, the impact of Ockhi cyclone can be evidently noticed in fair weather 2017 and premonsoon 2018 seasonal profiles. The coast was undergoing processes to recover from this impact which can be observed from fair weather seasons comparison plot.

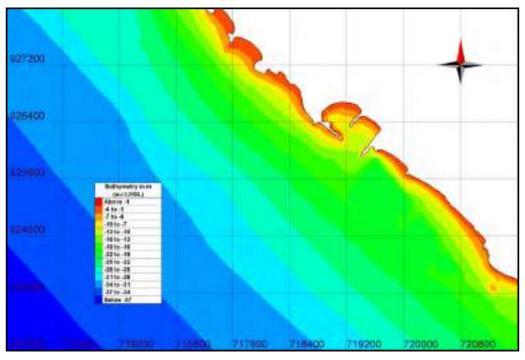
Figure 3-23 Post-Monsoon (2019) bathymetry with respect to MSL

Also, model was setup using latest surveyed bathymetry as on date i.e. Post Monsoon 2019. The same calibration parameters and boundary conditions as discussed in earlier sections are used to simulate hydrodynamics. The model bathymetry prepared using the available primary and secondary data is shown Figure 3-23.

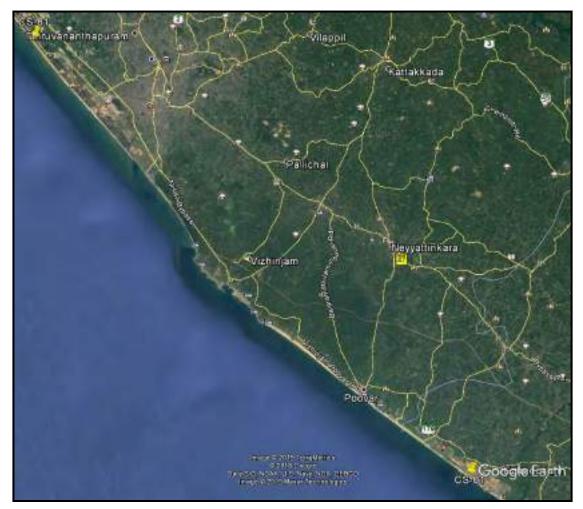
Figure 3-35 Study area

The study area extends from Edappadu Beach (CS 01) in the South to Thumba (CS 81) in the North over a stretch of approximately 40km as shown in Figure 3-35. This coast can be distinguished into two subsets depending on the coastal orientation. The shore angle on south side is in the range of 125° to 130° (True North) and shore angle on north side is in the range of 135° to 145° (True North). These orientations were shown with green and maroon lines in Figure 3-36. This change in orientation will have effect on long shore sediment transport and its behaviour.

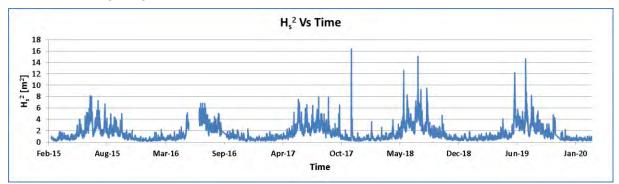
The following graph represents the square of the Hs versus time. The square of the Hs is relatable to the energy of the wave. This shows good correlation with the principal component 1 temporal plot as we can notice the berm formation during calm period and bar formation during rough season.

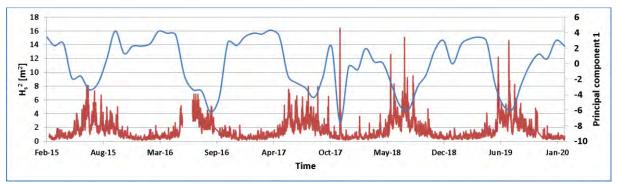
Figure 4-4 Graph showing temporal variation of H_s² and principal component 1

The following graph shows temporal variation of H_s^2 and principal component. It can be noted from this graph that the higher the H_s^2 , the lower the principal component and vice versa.
